Technical Review Report

## 2018 Work Scope for Appendix No. 6 Findings of the Technical Review Team

**Water Resources Agency  
Ministry of Economic Affairs, Taiwan**

Technical Review Report  
2018 Final Report Under Appendix No. 6

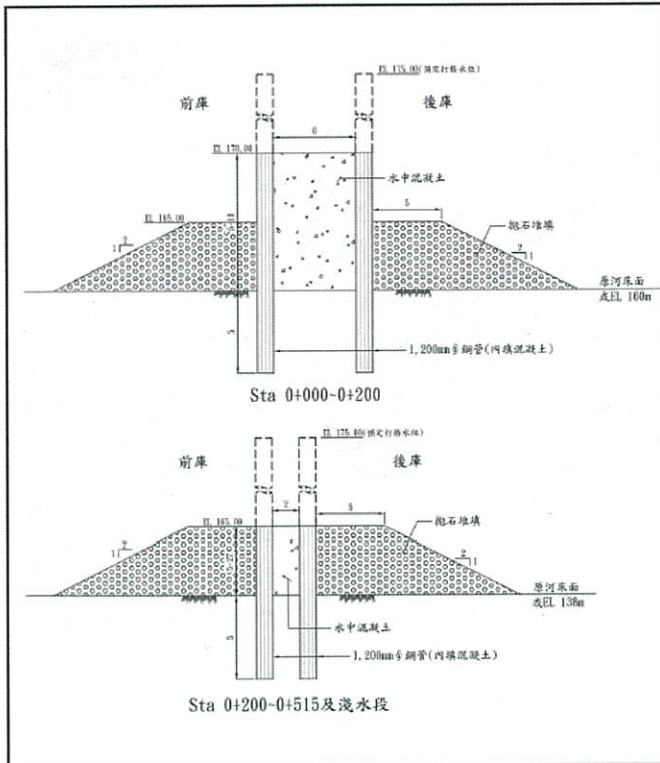
Figure 18. – Section of proposed submerged weir at Nanhua Reservoir

- Concern that coarser material (sand, gravel, cobbles, and boulders (up to 1 meter diameter)) will damage the concrete lining of the tunnel as velocities approach 30 m/sec.
- In the event the sluicing tunnel is overwhelmed during torrential rain, there is concern that high-velocity flows could erode the submerged dam. However, the concrete core (2 meters thick) would likely remain intact.

- Consider constructing a physical model to assess how the submerged weir will perform during such a flood event
- Regarding how to improve the likelihood that the rock-fill materials associated with the submerged weir will stay in place, the following could be considered.

- Flatter slopes
  - Use of larger sized riprap
  - Grouted riprap
  - Other armoring for the riprap, such as a reinforced concrete overlay.
- Consider use of a physical model and/or consultation with sedimentation experts (Appendix 8) regarding an alternative to the submerged weir or trapping/diversion channel.

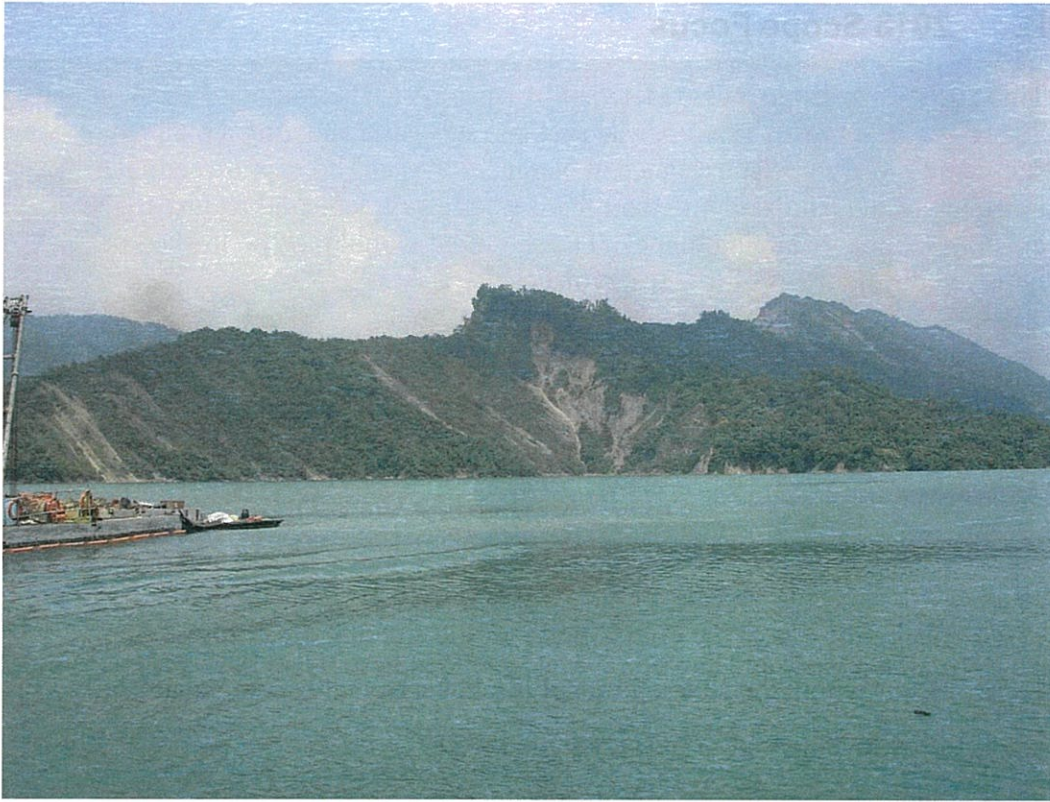
Photo 5. - Adverse Geology Related to Portal for Sluicing Tunnel

- The proposed submerged weir and sluicing tunnel portal are located at the toe of a bedrock dip slope that has unfavorable bedding orientations and historic landslides. See Photos 5 and 6. The long-term stability of this slope as it affects the project is a concern. Monitoring has indicated horizontal movement of the bedrock of approximately 0.5 cm per year.

- Submerged Weir and Portal –
  - Continue monitoring of survey points on the dip slope above the portal. Also consider use of newer technologies such as terrestrial lidar, radar, INSAR, photogrammetry to obtain baseline topographic survey so that detailed measurements of displacement can be monitored for comparison with future surveys.

- Perform a detailed slope stability analysis using all available data and the existing slope geometry, then perform a sensitivity analysis to assess the potential effects of erosion at the base of the slope.

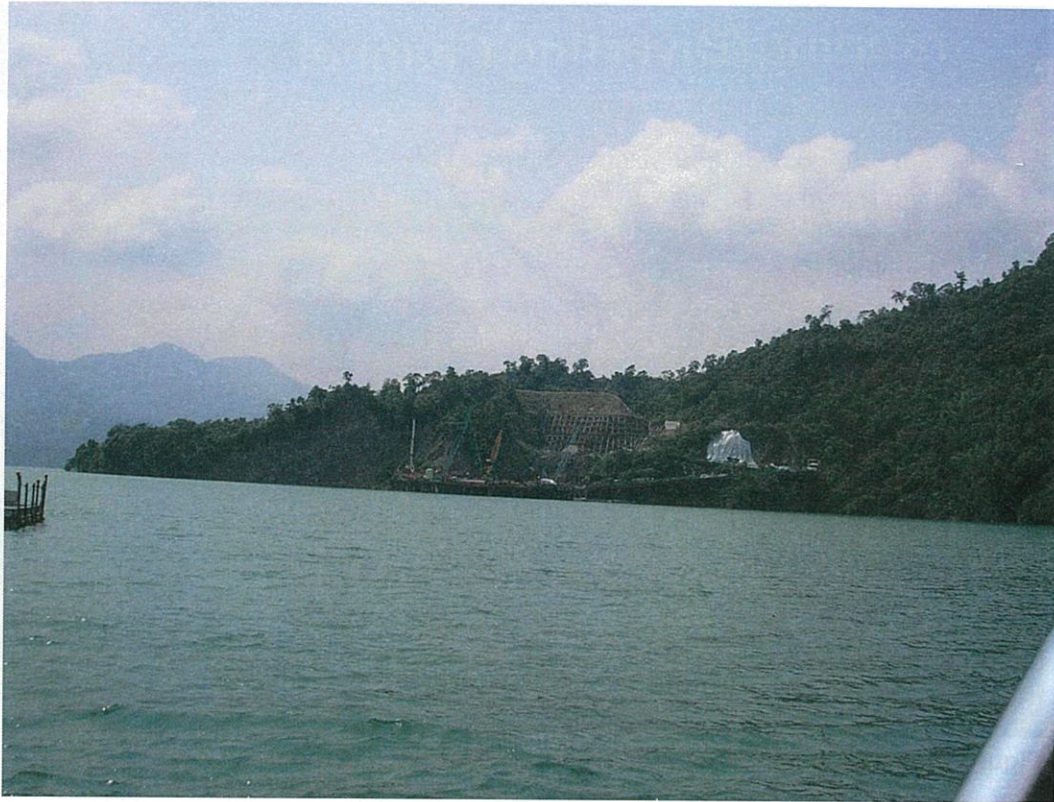
Photo 6. - Portal to Sluicing Tunnel

- Concrete lining damage - If not already considered, the compressive strength of the concrete lining could be further increased by adding silica fume to the mix design. Initiating and maintaining periodic inspections will be important. If damage does occur to the concrete lining, then concrete repairs can be made in a timely manner.

- Concrete lining damage - With time, it may be found that it is more economical to install a steel liner than to continue to make reoccurring costly concrete repairs. Dam safety and/or life loss do not appear to be a concern. This is because damage to the lining will be found and repaired in a timely manner, due to periodic inspections.

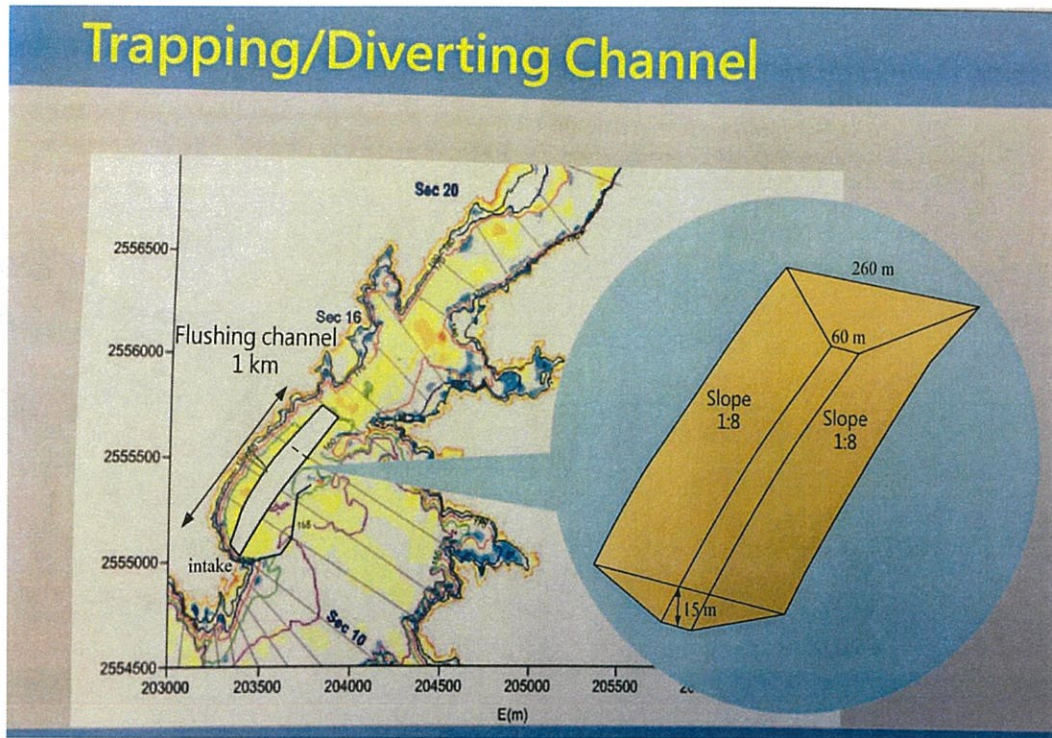
Figure 19. - Proposed Design for Trapping/Diverting Channel

- Figure 19 shows a design for a trapezoidal channel excavated into the upper reservoir basin as an alternative to the submerged weir to divert sediment into the desilting tunnel. There is concern about the effectiveness of this solution.

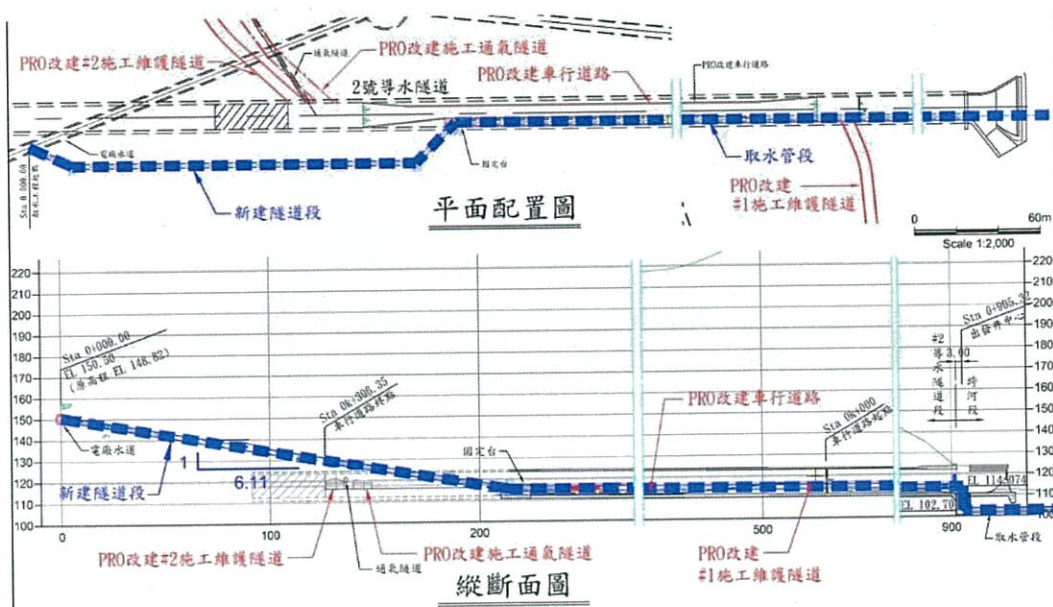
Figure 22. - Layout of the New Intake Tunnel of the Tsengwen/Nanhua Pipeline

- There is concern that proposed new tunnel excavation (shown in yellow will impact the integrity of the existing diversion tunnels. Analysis has been conducted using the simplified strength model of Hoek and Brown. This analysis does not address the site specific sandstone and shale foundation materials or associated discontinuities (joint sets, shear zones, faults etc.).

- Proposed tunnel excavation - It is recommended that an exploratory borehole be advanced along the proposed tunnel alignment to characterize the geology of the bedrock, and a kinematic analysis be conducted to determine if there are is any impact to the nearby diversion tunnels (removable blocks, etc.)
- Water Hammer - The gate can always be closed at an even slower rate to further reduce concerns.

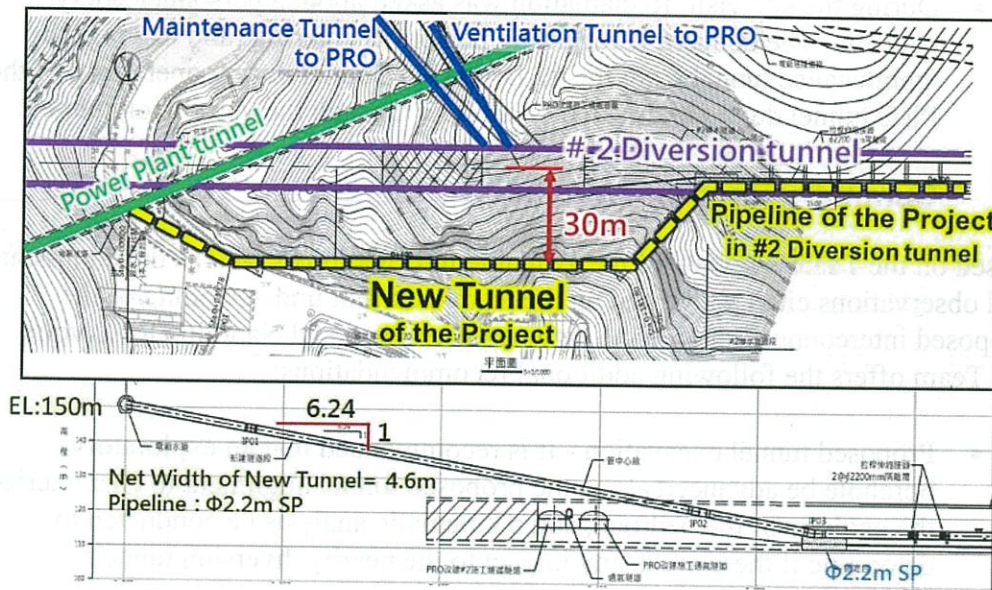
Figure 23. Tunnel Alignment and Profile

A portion of the pipeline will be installed in existing Tsengwen Diversion Tunnel No. 2 and will occupy part of the cross-sectional area of the tunnel as shown in Figure 23. WRA is interested in Reclamation's opinion regarding whether the ventilation required for Permanent River Outlet (PRO) will be affected.

- Regarding ventilation requirements for the PRO, the decrease in cross-sectional area in the #2 Diversion Tunnel (due to construction of the pipeline and its support) is about 19 percent. There is concern that a reduced cross sectional area could have adverse effect on ventilation requirements for the PRO.

- Ventilation - If not done already, air-demand calculations can be completed to determine if the PRO can operate as designed, and if air velocities will be excessive in the system.
- Personnel Safety - A concrete wall could be constructed within the #2 Diversion Tunnel to separate the high velocity air flow from personnel entering (or leaving) the maintenance tunnel. The wall would be constructed parallel to air / personnel traffic, be approximately be approximately 3 meters in height, 0.3 meters thick, and an appropriate length. Personnel could then safely, and comfortably, access the maintenance tunnel during operation of the PRO tunnel.
