# 112年度鰲溪流域管理平台 第一次大平台

## 鰲溪治理概述

報告單位：第九河川局

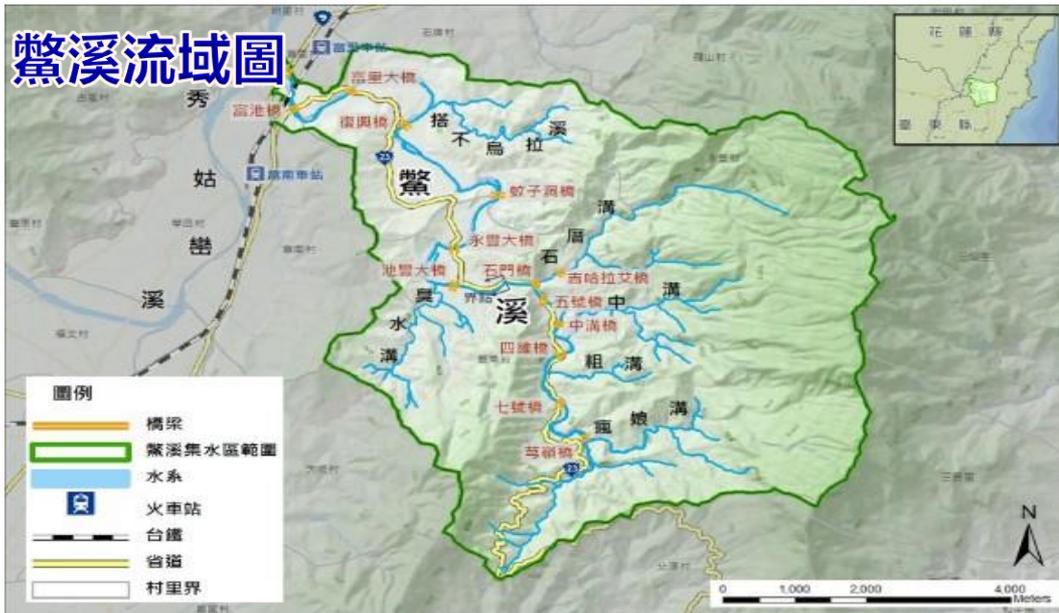
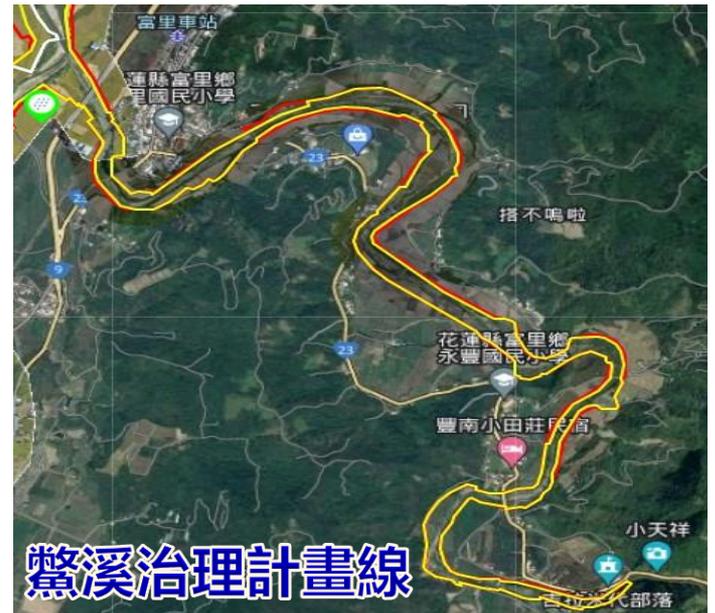
➤ 治理範圍 吉拉米代部落前攔砂壩上游100公尺至與秀姑巒溪匯流口  
(全長約9.3km) ※流域長度16.91km

➤ 治理概況 ➤ 全線已興建堤防護岸 5763 m

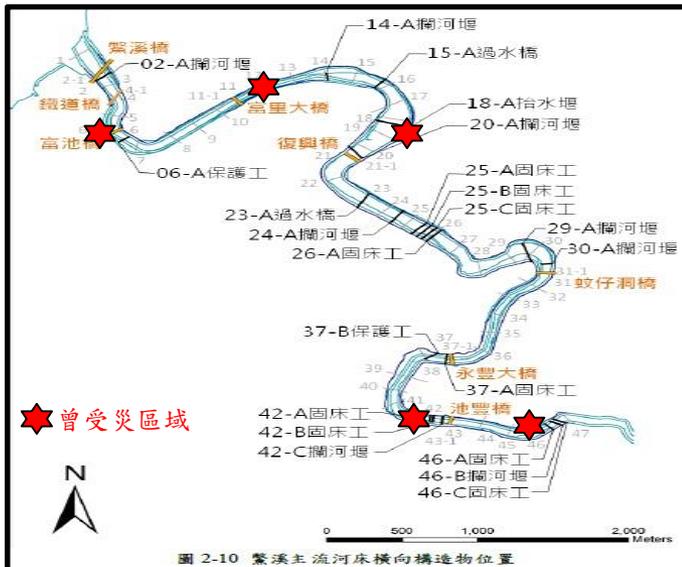
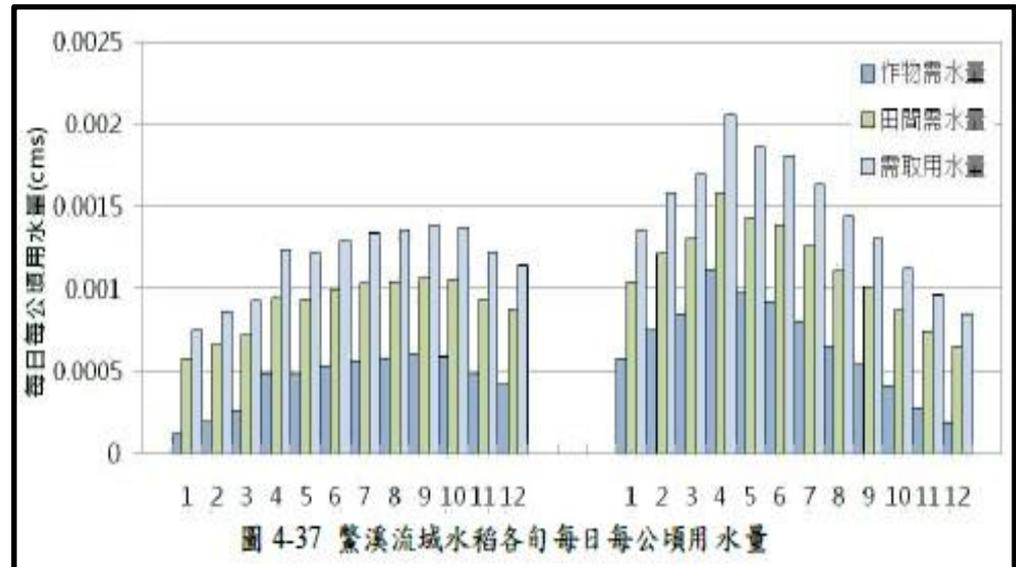
- 民國108年3月本局成立鰲溪流域管理平台並擬定鰲溪整體復育策略與行動方案
- 經盤點鰲溪物理棲地之復育面臨三項主要課題(節錄自「109年12月鰲溪河川復育方案」)
  - ◆ 鰲溪主流界點下游現有23座橫向構造物，影響生態棲地
  - ✓ ◆ 鰲溪河道自民國69年起，即逐漸下切，使局部堤岸及橫向構造物受災頻繁。
  - ◆ 鰲溪現採粗放式灌溉管理，九座混凝土攔河堰因河床下切或堰體下伏流導致取水困難。

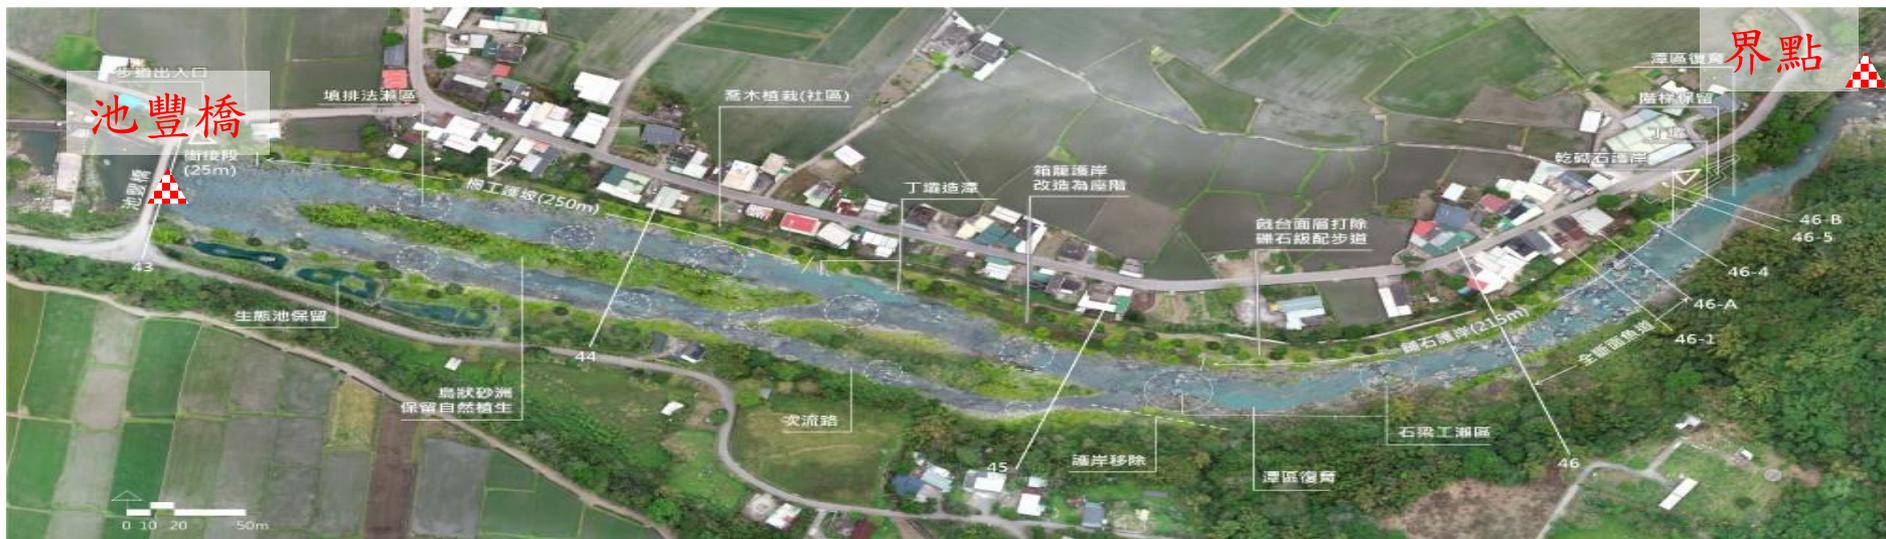
本計畫選擇界點至池豐橋(鄰近豐南社區)河段為短期示範區，依河段環境概況與課題，提出方案規畫與初步設計，說明工序與工法，並檢核設計之安全性。

- (一) 規畫移除46-B攔河堰、8m高擋土牆上部、戲台面層等構造物，填高河床0.8至4.8公尺。挖掘左岸次流路，以近自然工法建置全断面魚道、石梁工、丁壩等，恢復健康潭瀨分布。新建砌石、鋪石、柵工等護岸並保留現有箱籠護岸，配合植樹保護河岸，同時營造便於社區利用的緩坡親水空間。
- (二) 規畫內容皆不涉及私有地，屬短期可行，第一年以挖填方為主，第二年以近自然工法為主。
- (三) 檢核改善前後河段水勢、水位，並計算近自然工法之力石(keystone)安定性，確認規畫內容符合防洪需求，且大幅減緩水勢，可提升安全性。

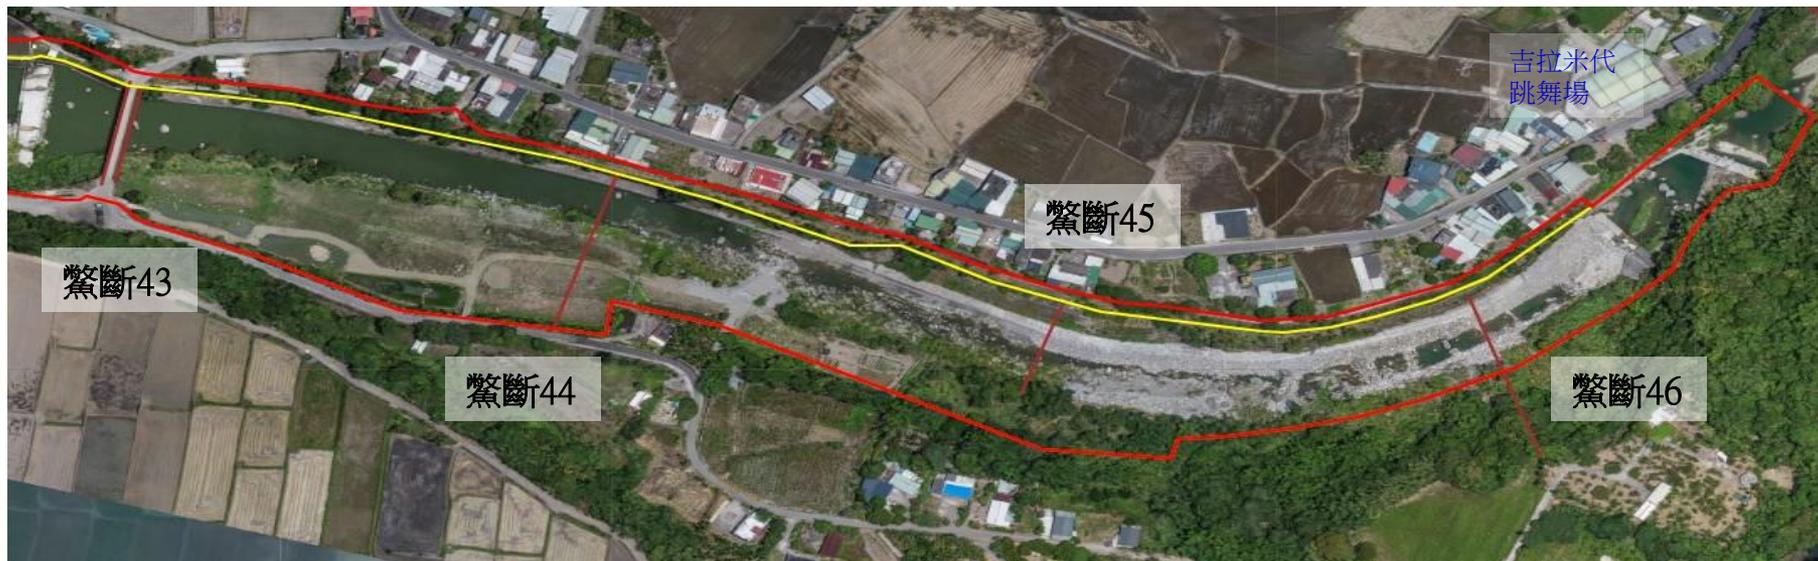
- ◆ **復育範圍及經費：** 本局參考「109年12月鯿溪河川復育方案」內容預計復育鯿溪斷面43~46之河段，並已於112年3月1日提報水利署爭取相關經費。
- ◆ **設計方向：** 相關設計內容未來將委託專業設計團隊辦理，期望採近自然工法之方式施作，日後將召開地方說明會詳細說明。
- ◆ **預計期程：** 112年底前設計發包，期望113年工程發包。
