經濟部水利署第九河川局

秀姑巒溪加納納堤段 河道整理改善工程 核定階段生態檢核說明

110年 11月 3日

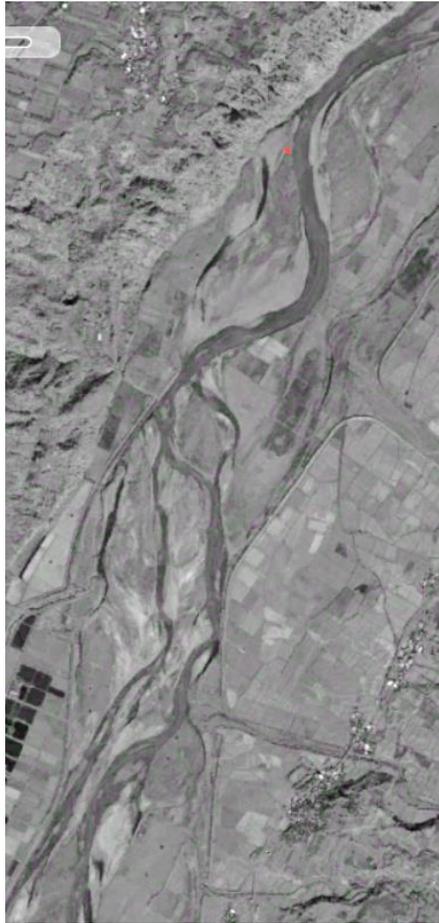
2010/11

辮狀河道演變情形

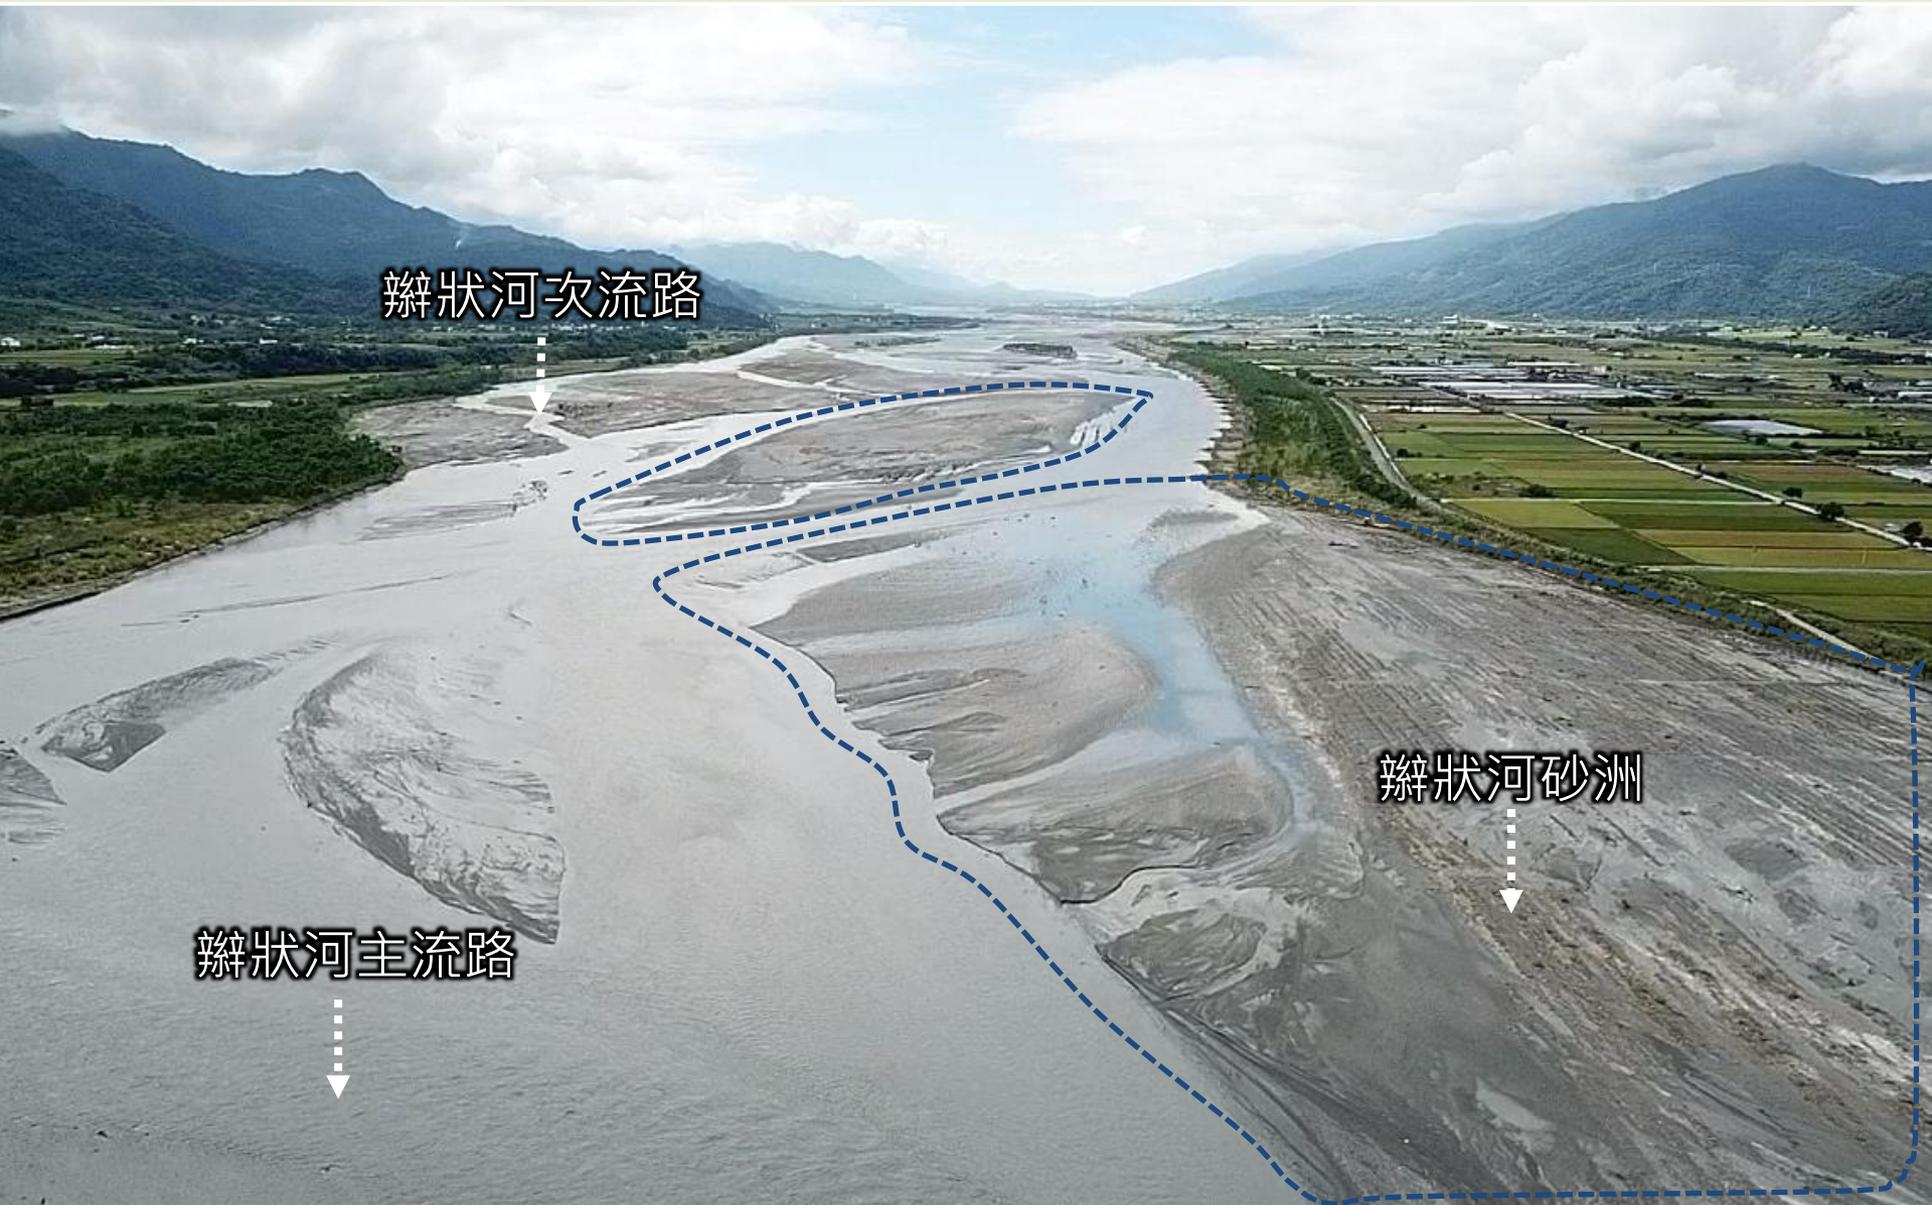
辨狀河次流路

辨狀河砂洲

辨狀河主流路

健康的辮狀河棲地

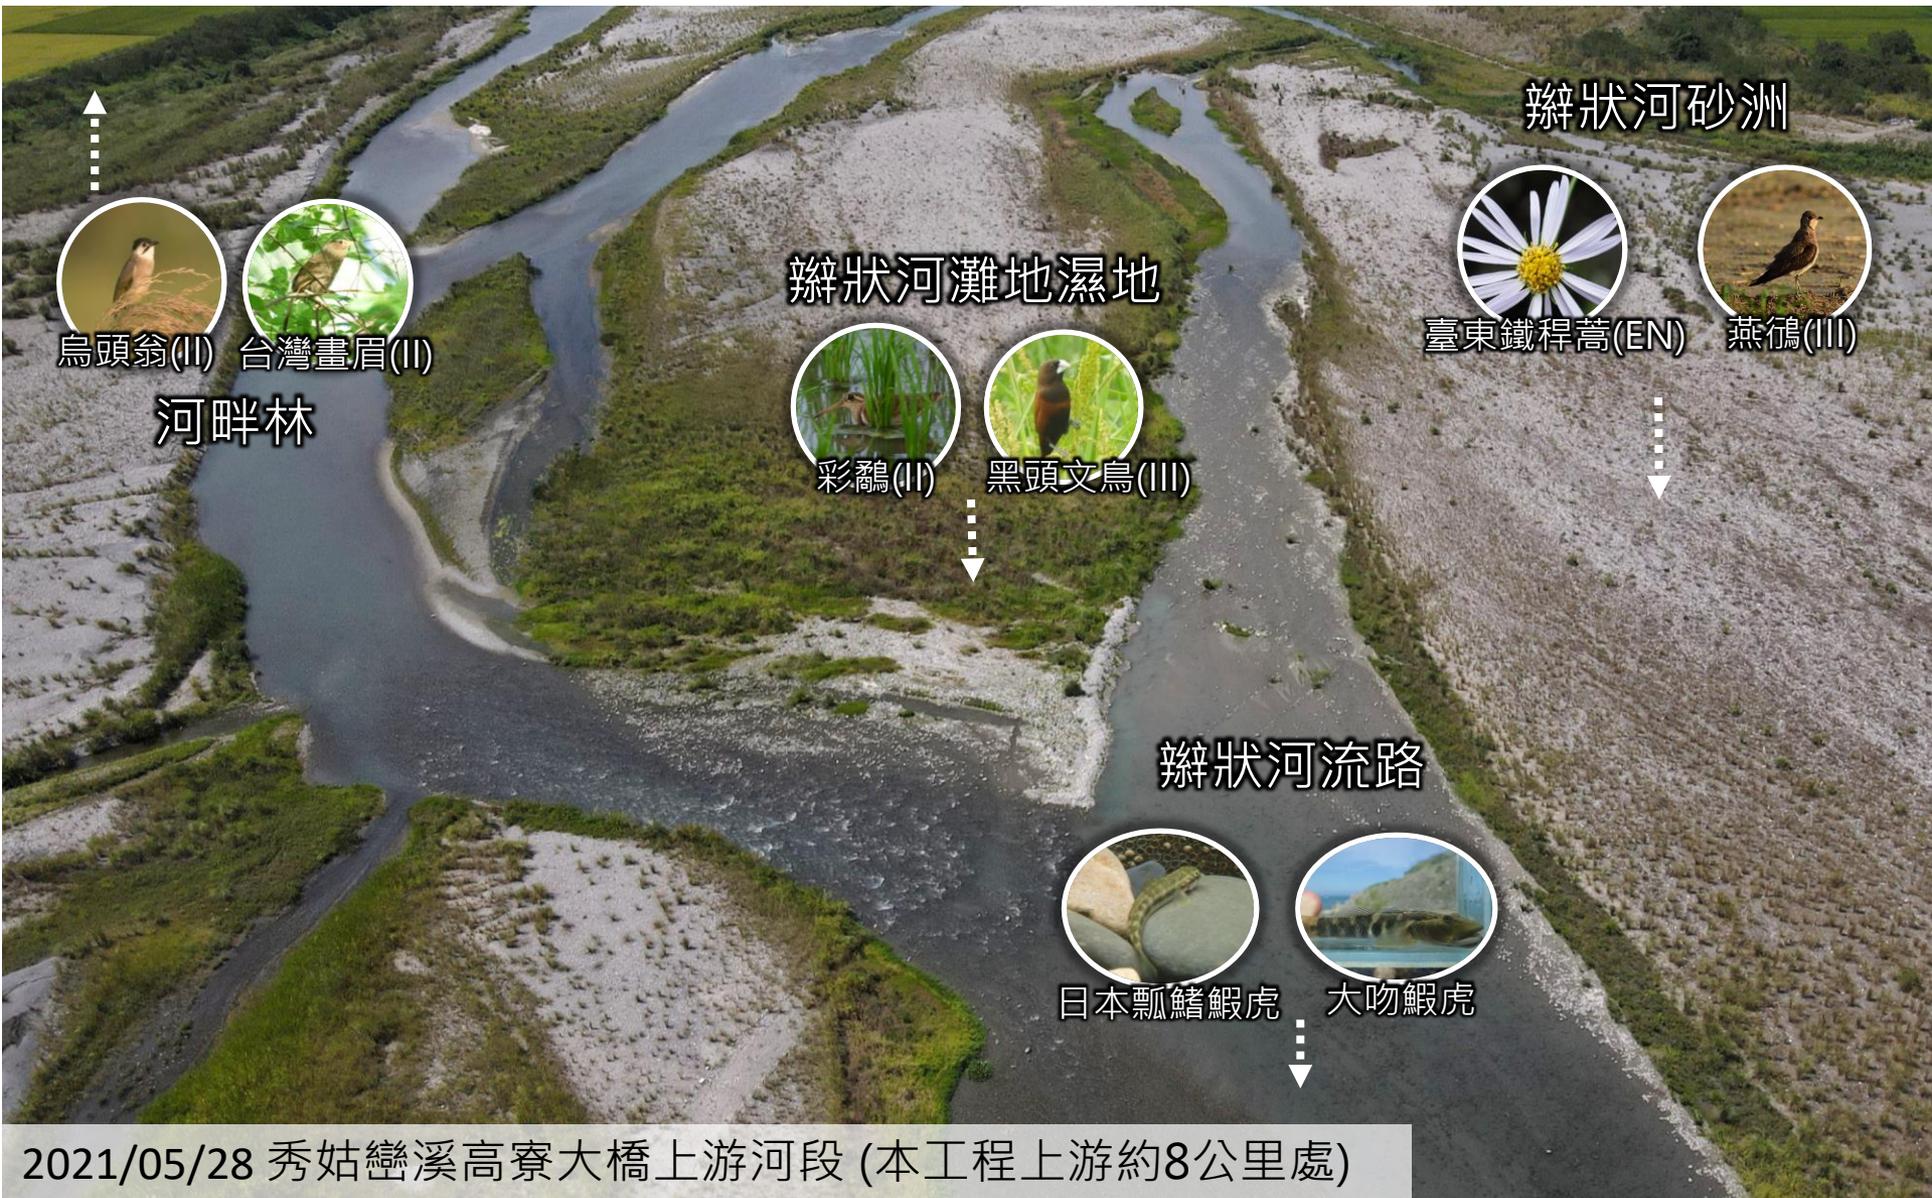
2021/05/28 秀姑巒溪高寮大橋上游河段 (本工程上游約8公里處)

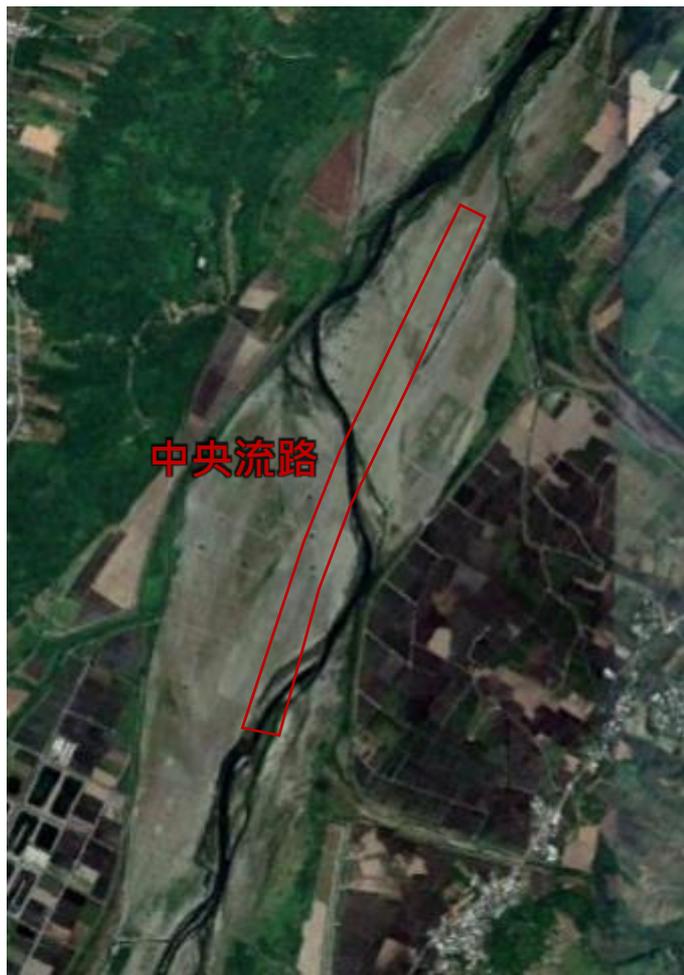
● 中央流路採緩坡設計

棲地類型單調

深槽化
流路

棲地類型多樣

辮狀河砂洲
辮狀河
流路
辮狀河灘
地濕地
辮狀河灘
地濕地

- 中央流路採緩坡設計，讓淺水處能夠生長植被。
- 回復溪流自然演變出多樣性棲地的能力。

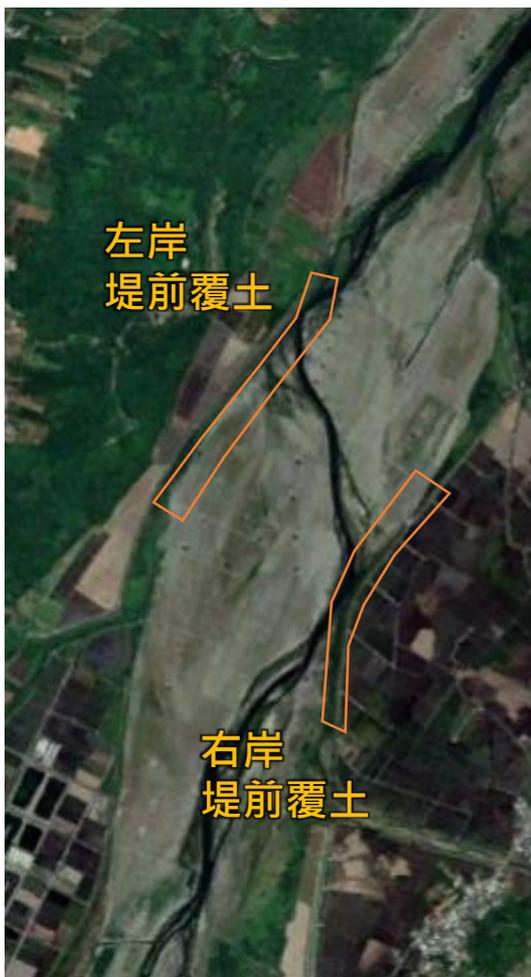
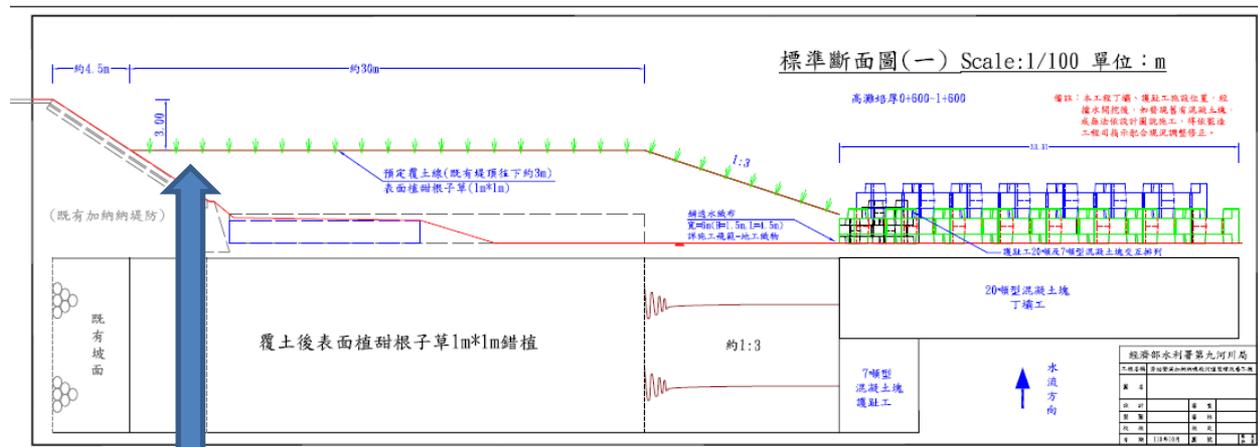
● 兩岸堤前覆土處扦插植被、導流水保護水域棲地

- 覆土處扦插甜根子草，抑制銀合歡生長。
(於設計階段積極尋找栽植喬木或灌木的可能性)
- 復育「高草莖植被棲地」，提供黑頭文鳥、烏頭翁等鳥立利用。
- 工程涉及水域棲地之處，先行引流水路，避免工程造成水質混濁。
