# 秀姑巒溪加納納堤段河道整理改善工程 第一次地方說明會(先期作業)

主辦機關：經濟部水利署第九河川局

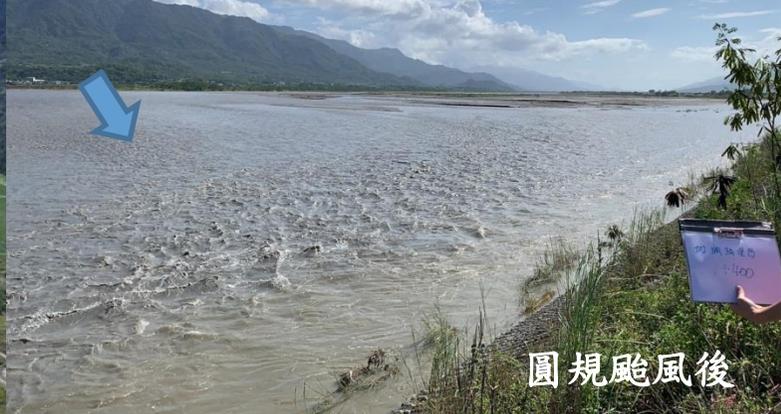
日期時間：2021年10月15日 下午 01:40:00  
TWD97TM2：287413.856, 2594171.960

圓規颱風後

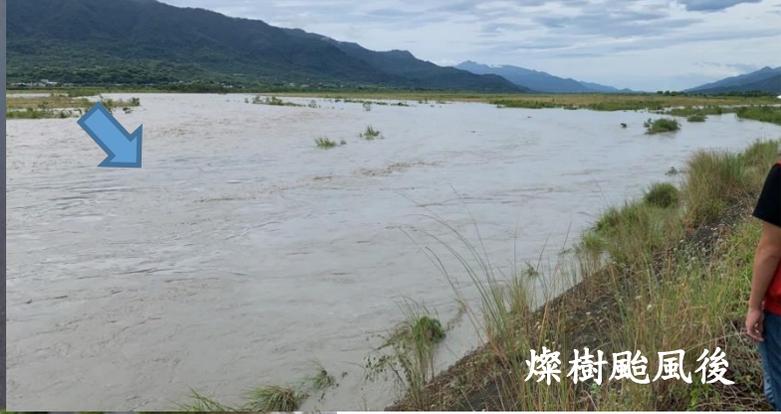
日期時間：2021年09月12日 上午 09:44:27  
TWD97TM2：287410.458, 2594161.676

燦樹颱風後

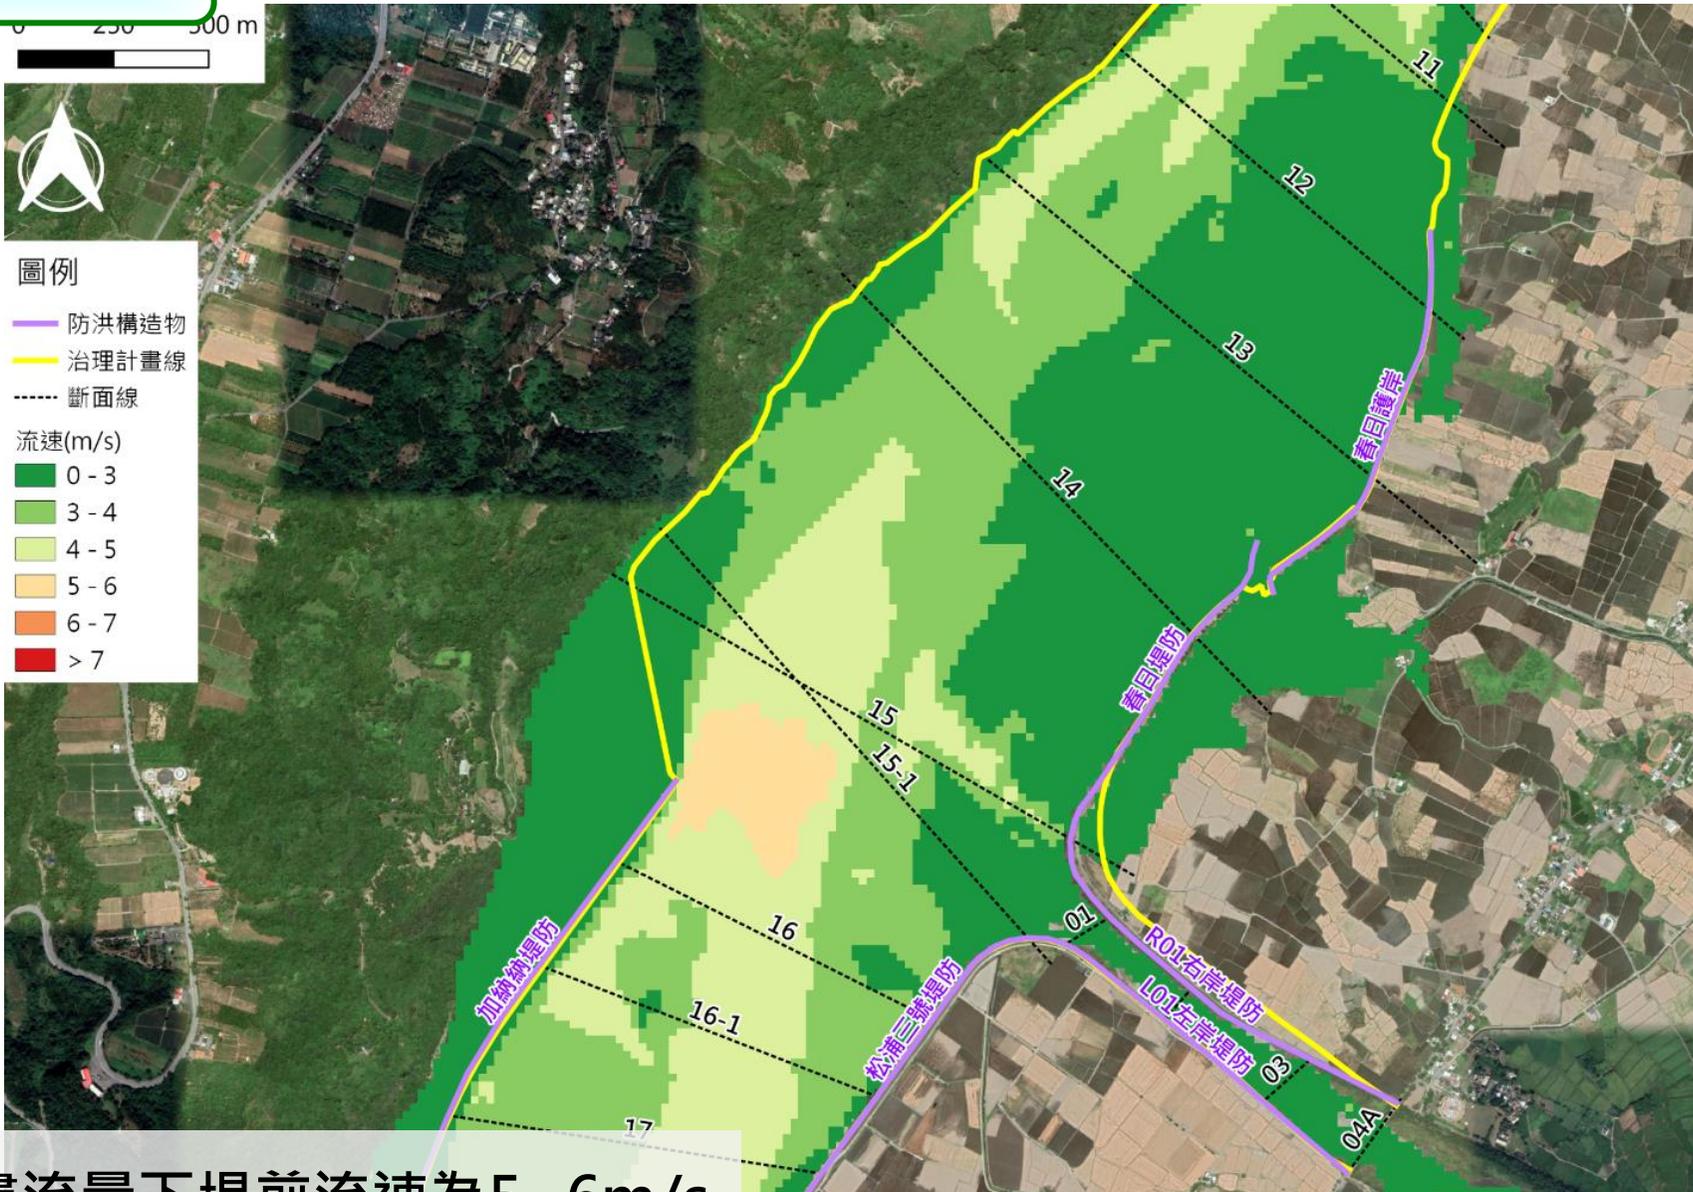
# 模擬成果

➤ 計畫流量下堤前流速為5~6m/s

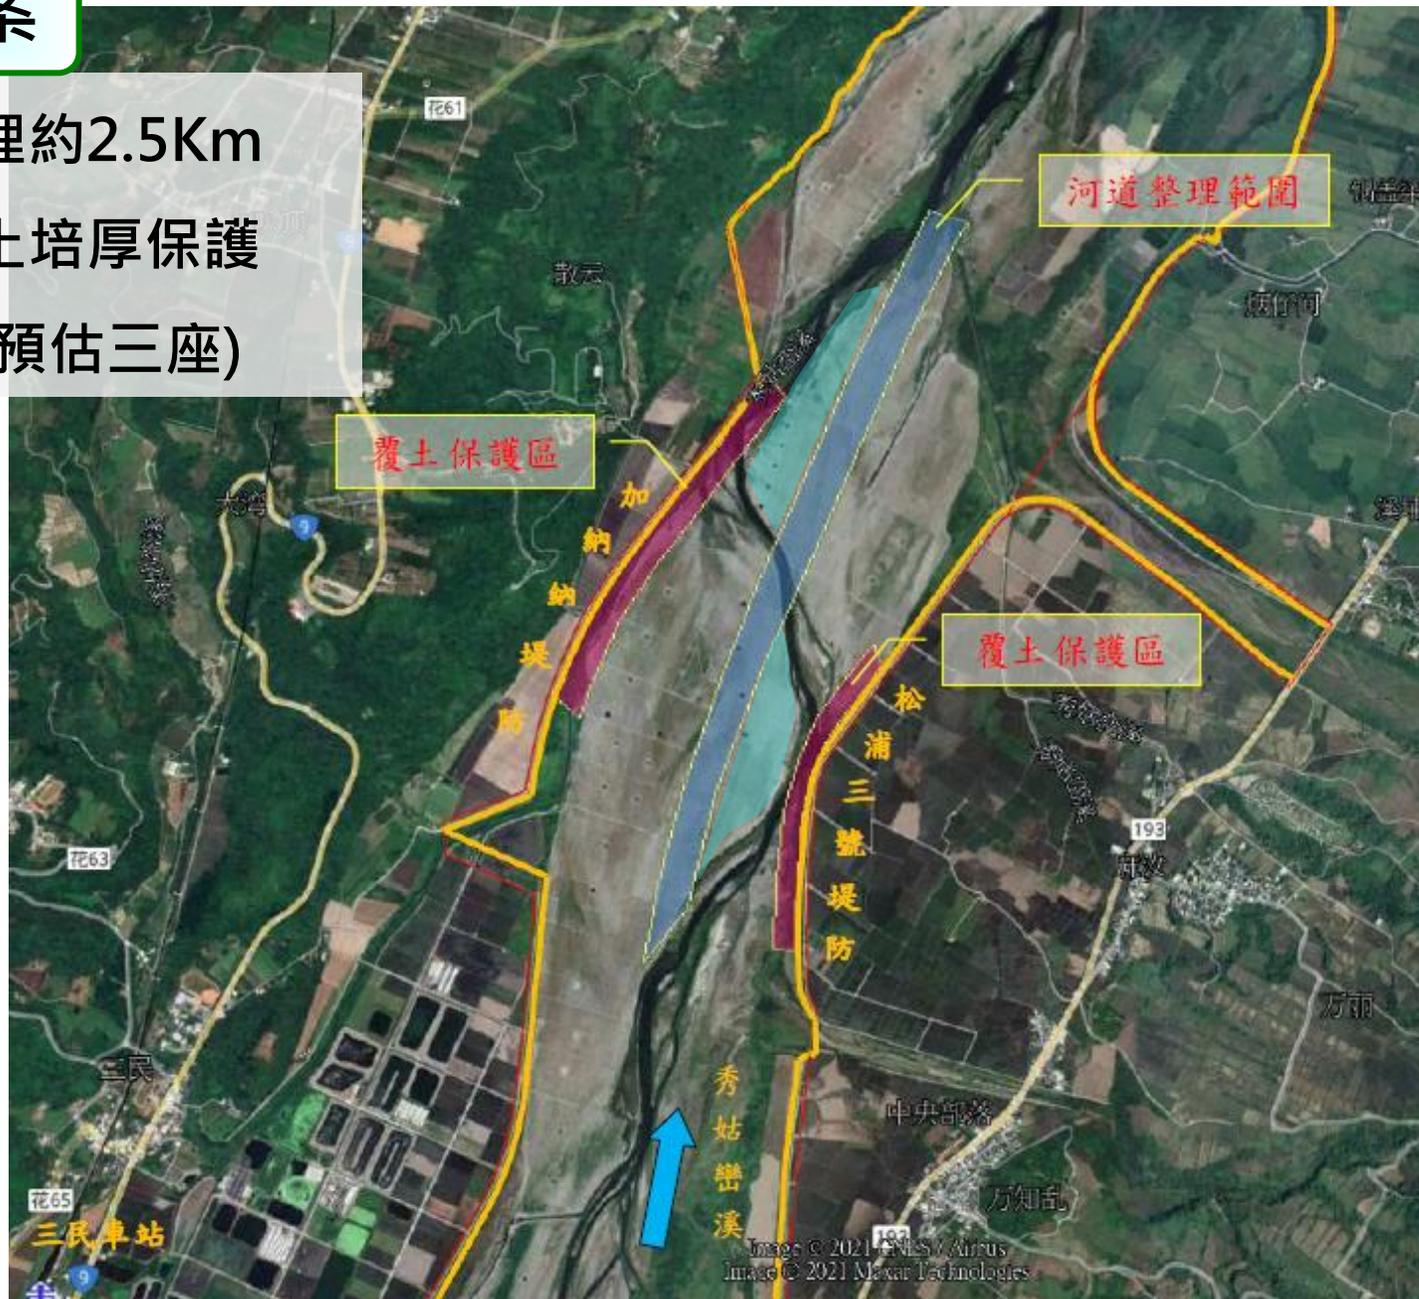
# 計畫方案

- 河道整理約2.5Km
- 堤前覆土培厚保護
- 丁壩工(預估三座)

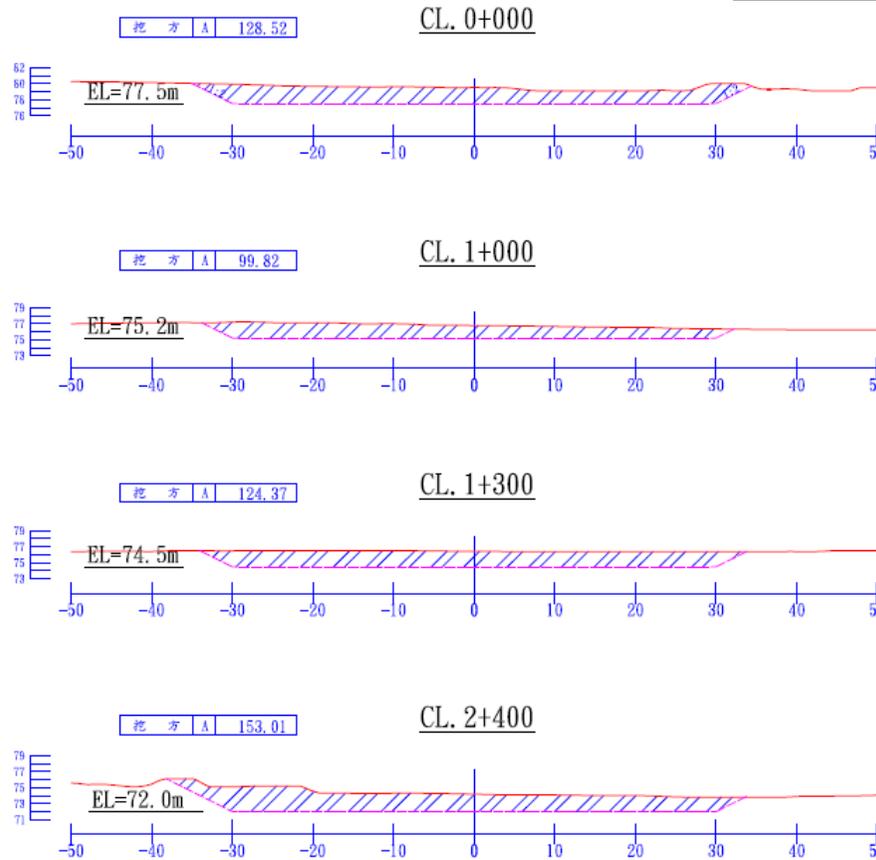
河道整理斷面圖(一) Scale: 1/500

- 河道整理區：
1. 兩側需以1:2土坡修順。
  2. 縱向至少每25m放樣控制高程。
  3. 整理完成後，廠商應先繳交自主檢驗(測量)成果，送監造單位檢覈後申請分段查驗。
