經濟部水利署第九河川局  
The 9<sup>th</sup> River Management Office, WRA

觀察家生態顧問有限公司  
Observer Ecological Consultant Co., Ltd

# 苓雅溪左岸堤防改善工程 核定階段地方說明會 生態檢核說明

111 年 6 月 6 日

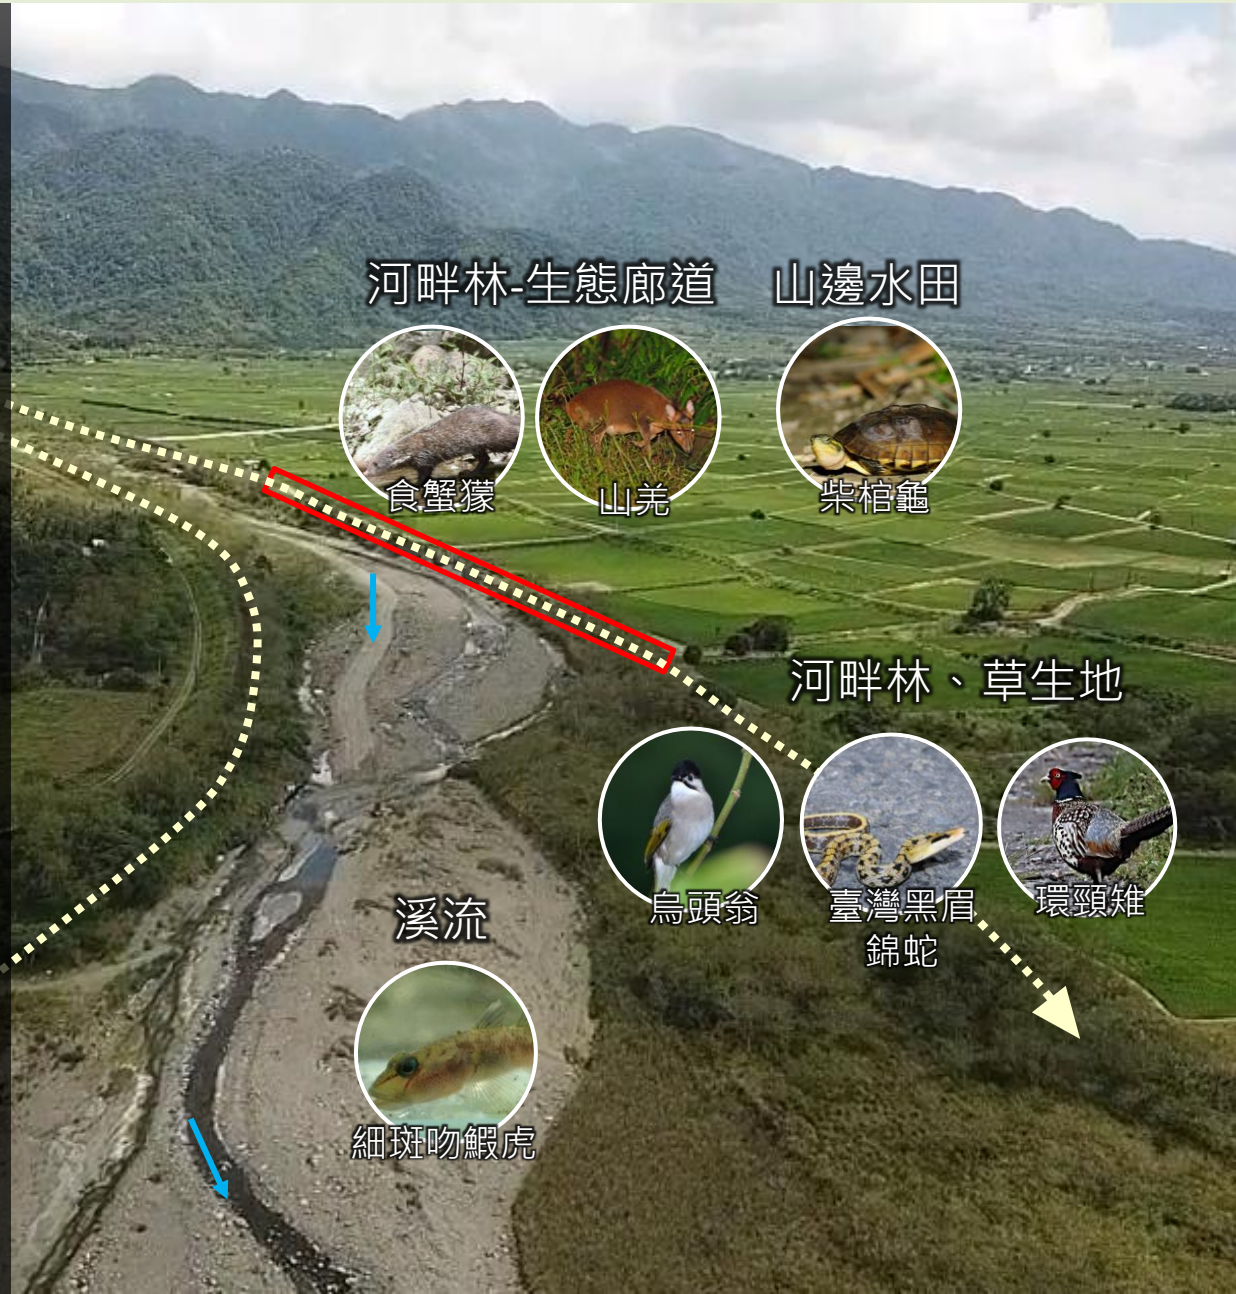
## 工區影響棲地及物種:

1. 山邊水田-  
柴棺龜
2. 河畔林(縱向生態廊道)-  
食蟹獾、山羌
3. 河畔林與草生地-  
烏頭翁、臺灣黑眉錦蛇、  
環頸雉
4. 溪流-  
細斑吻鰕虎

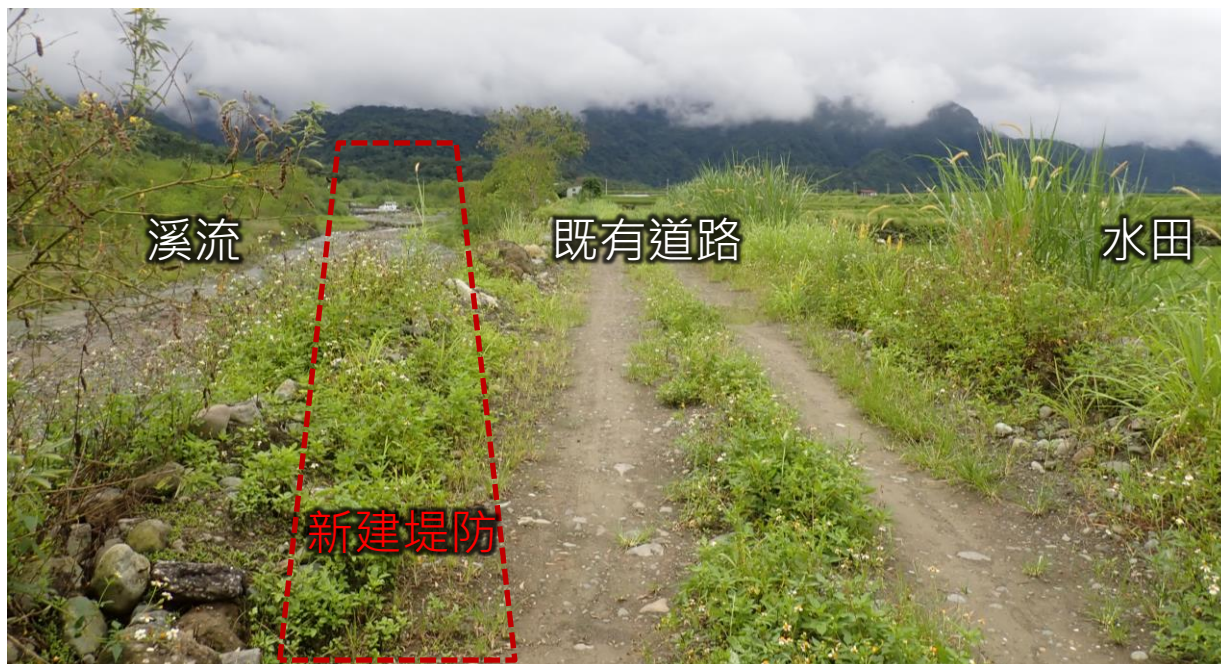
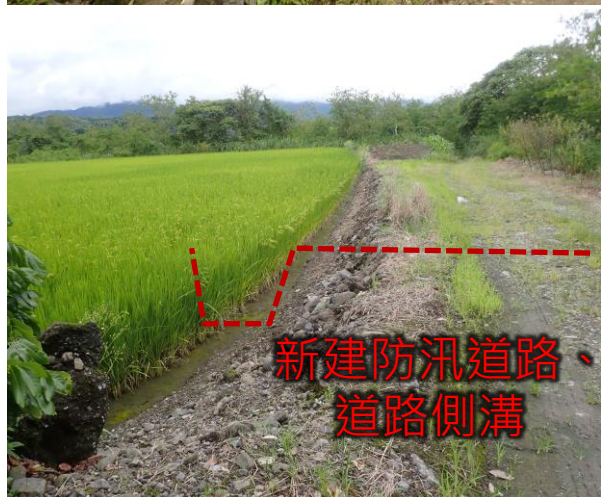
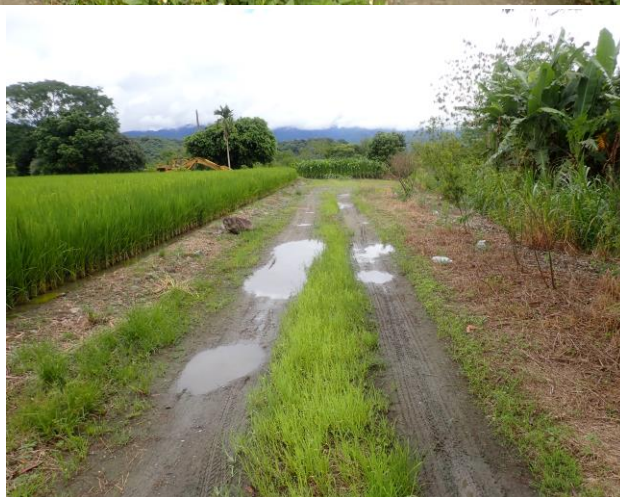
# 生態環境影響及保育措施

## 堤防

1. 緩坡化、綠化

## 防汛道路

1. 自然鋪面
2. 保留車轍之間的綠帶
3. 增設穿越道路的生物廊道。

## 道路側溝

1. 維持原貌
2. 緩坡化

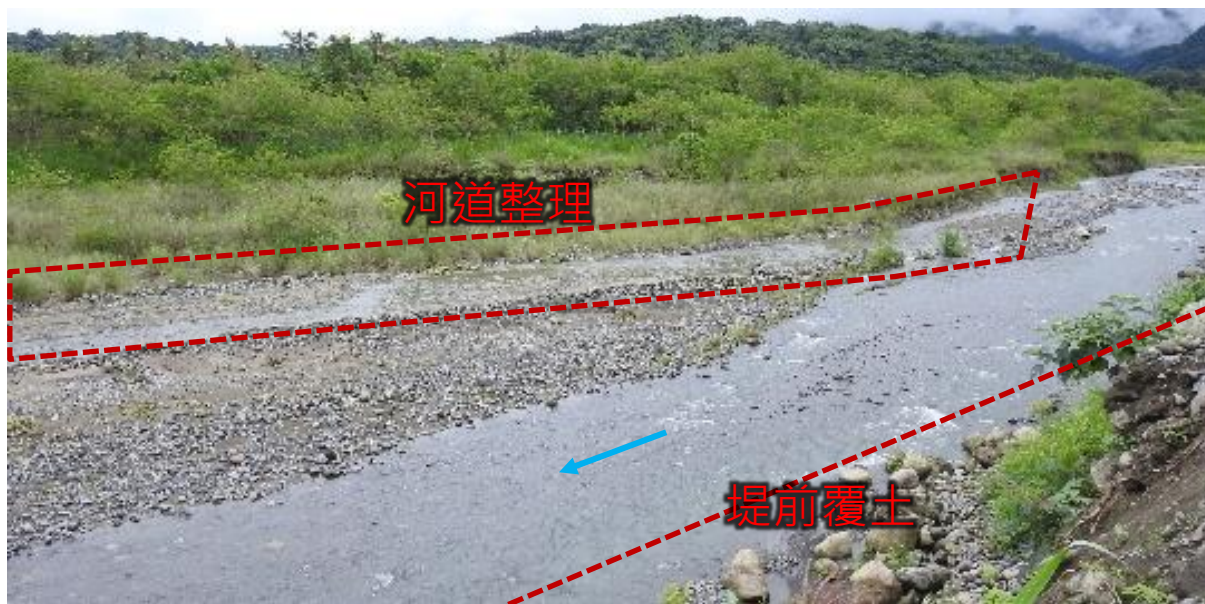
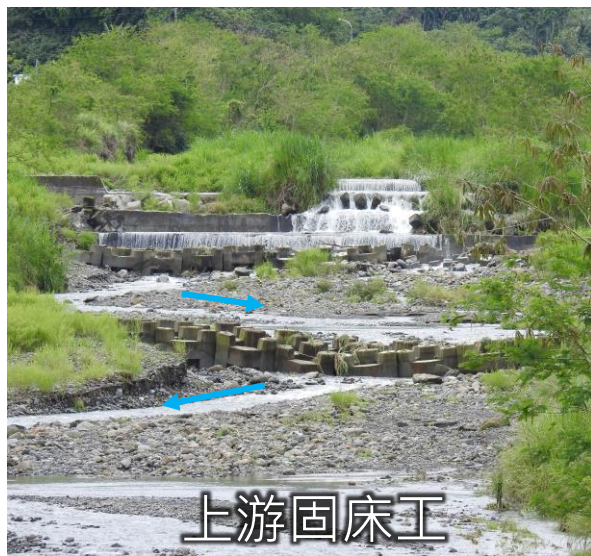
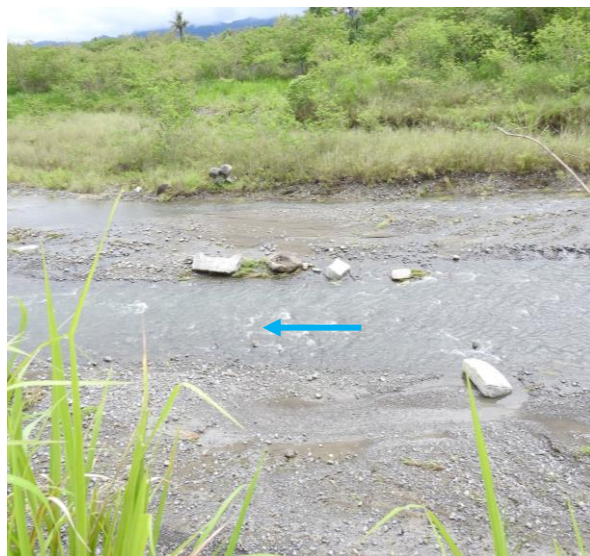
# 生態環境影響及保育措施

## 河道整理

1. 保留至少10公尺寬的濱溪帶。
2. 預先施作導流水措施，營造新流路，保持既有流路及新流路並流至少3天

## 堤前覆土

1. 完工後栽植原生植物以補償河畔先驅樹林棲地功能。
