Sediment Monitoring and Sluicing Operation in Shihmen Reservoir

**Water Resources Planning Institute, Water Resources Agency
Taiwan, ROC
Chiang, Ming-Lang**

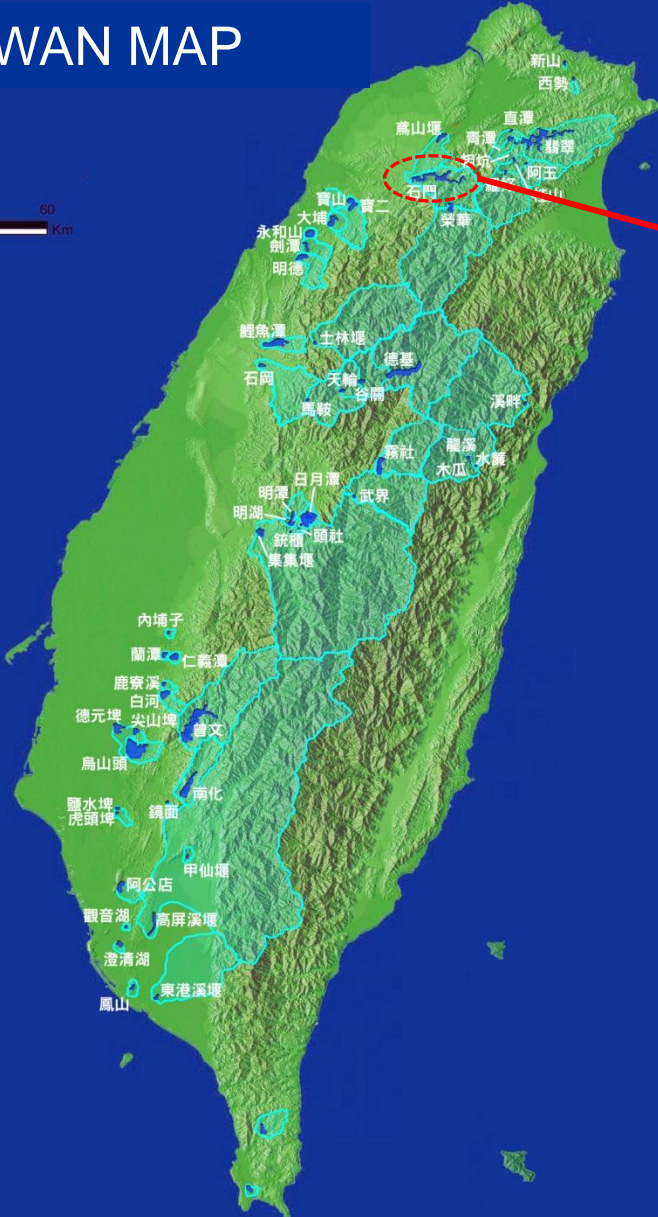
TAIWAN MAP

Shihmen Reservoir plays an important role on water supply for irrigation and domestic use of northern Taiwan.

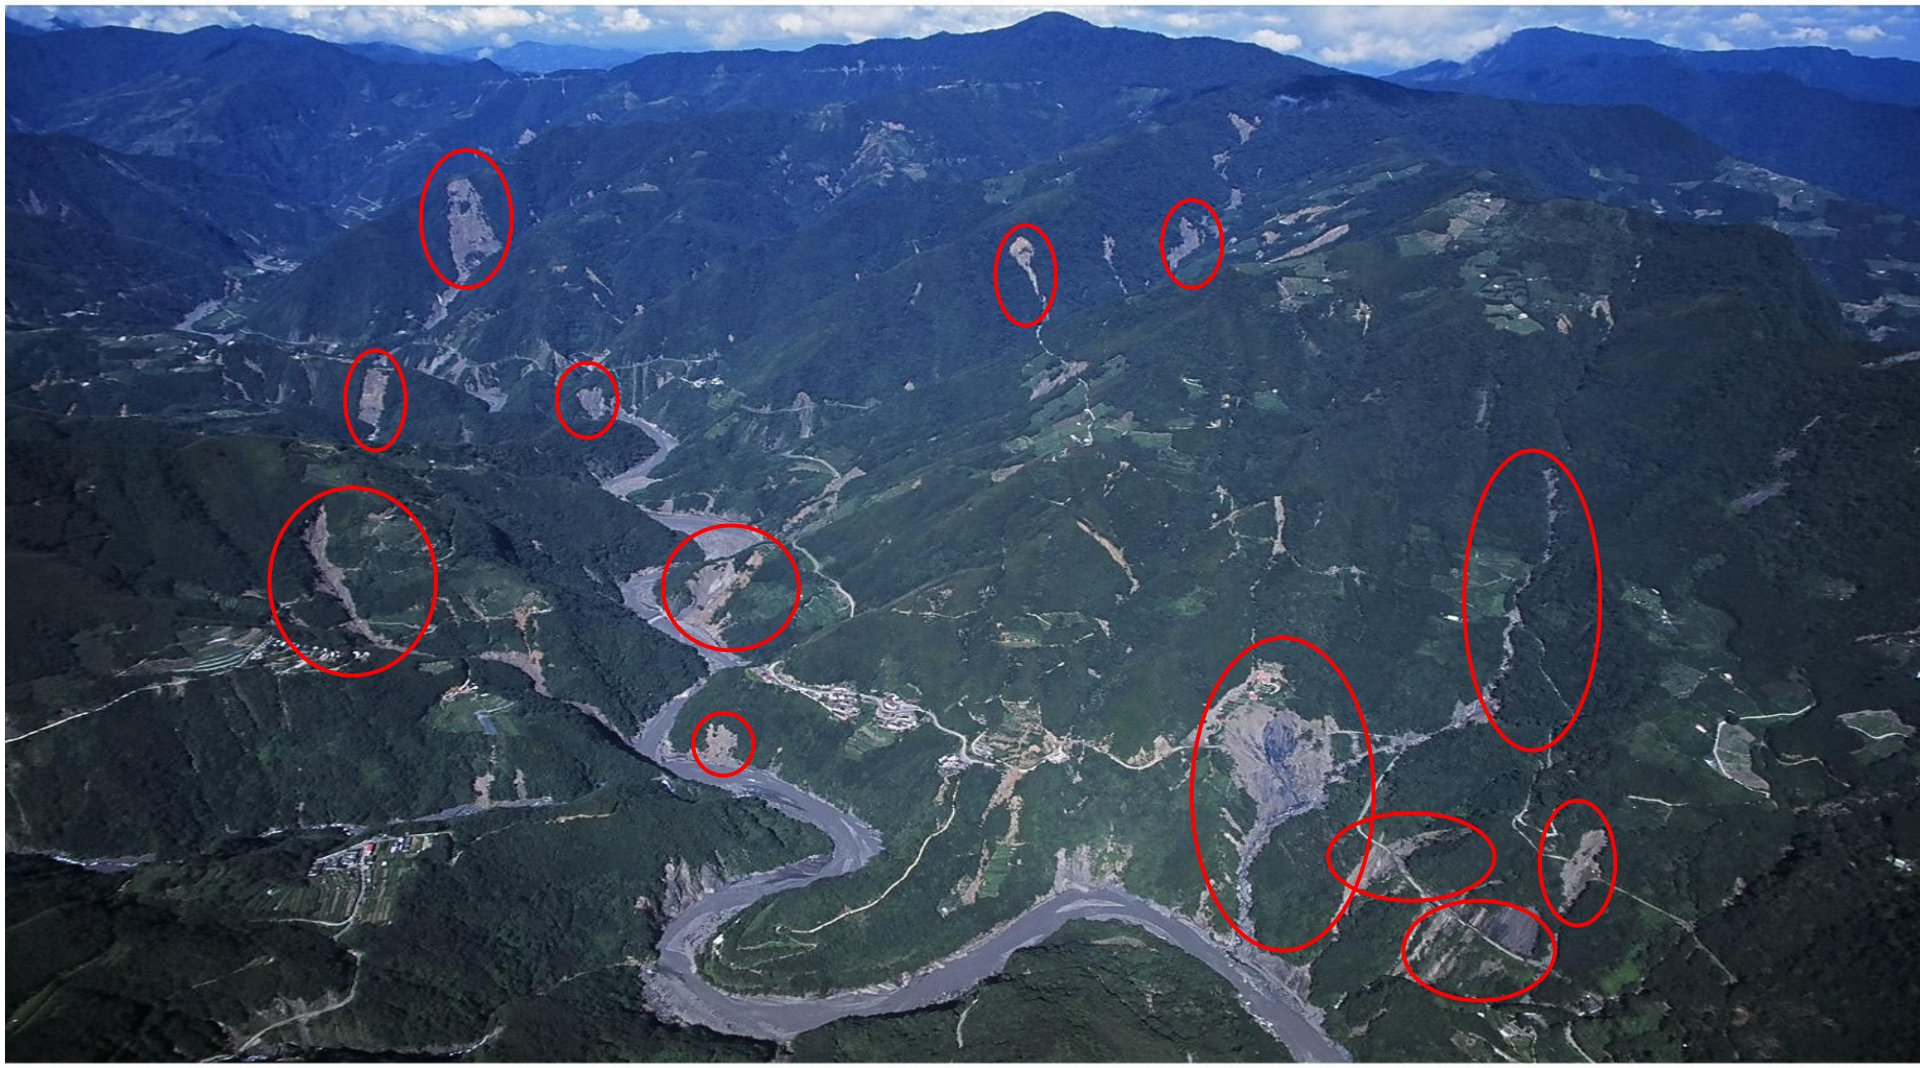
Landslides and soil erosion in watershed is the greatest threat to the reservoir.

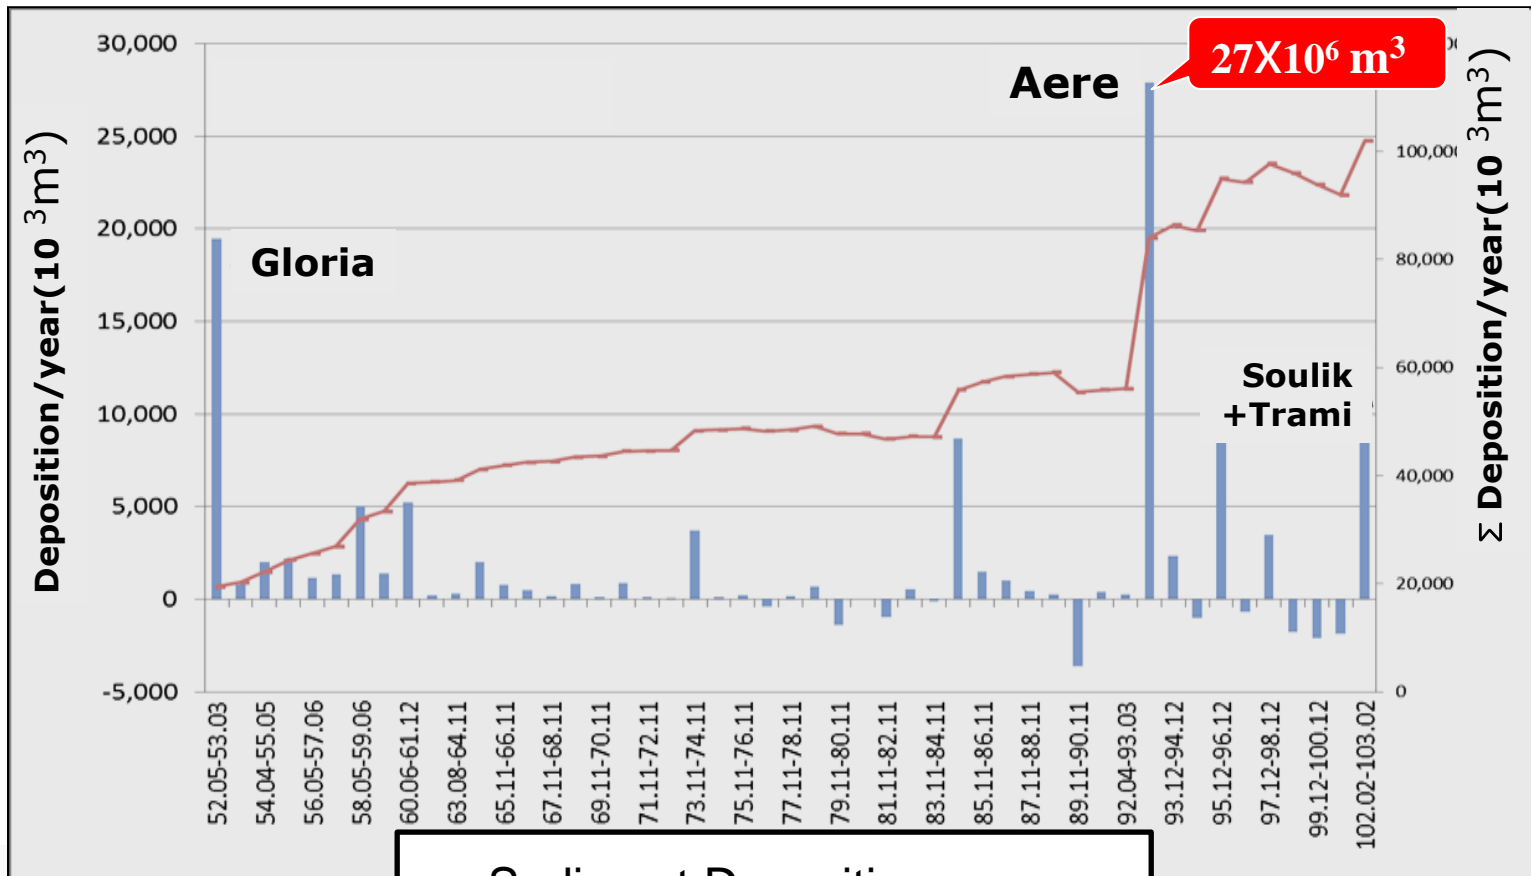
Sediment Deposition curve

Typhoon is the greatest factor for sedimentation.

Average deposition : $4 \times 10^6 \text{ m}^3/\text{yr}$

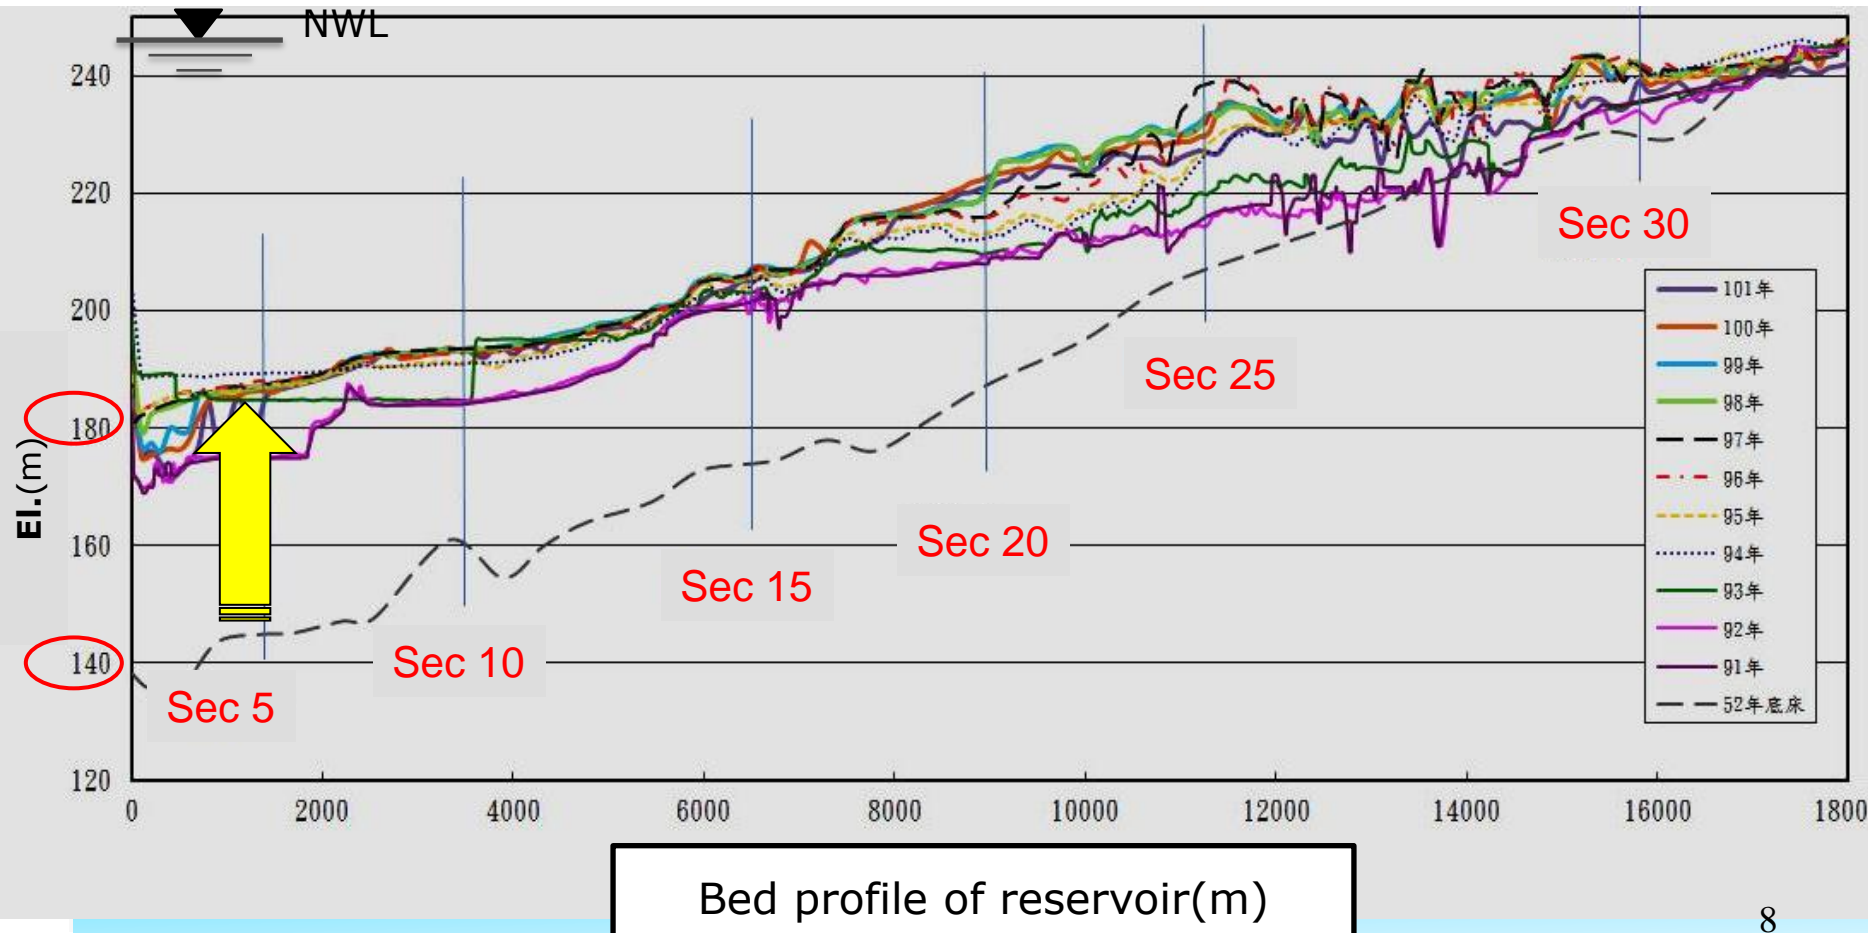
1/3 of the capacity were occupied by deposition.

Design capacity:
 $309 \times 10^6 \text{ m}^3$

2014 capacity:
 $207 \times 10^6 \text{ m}^3$

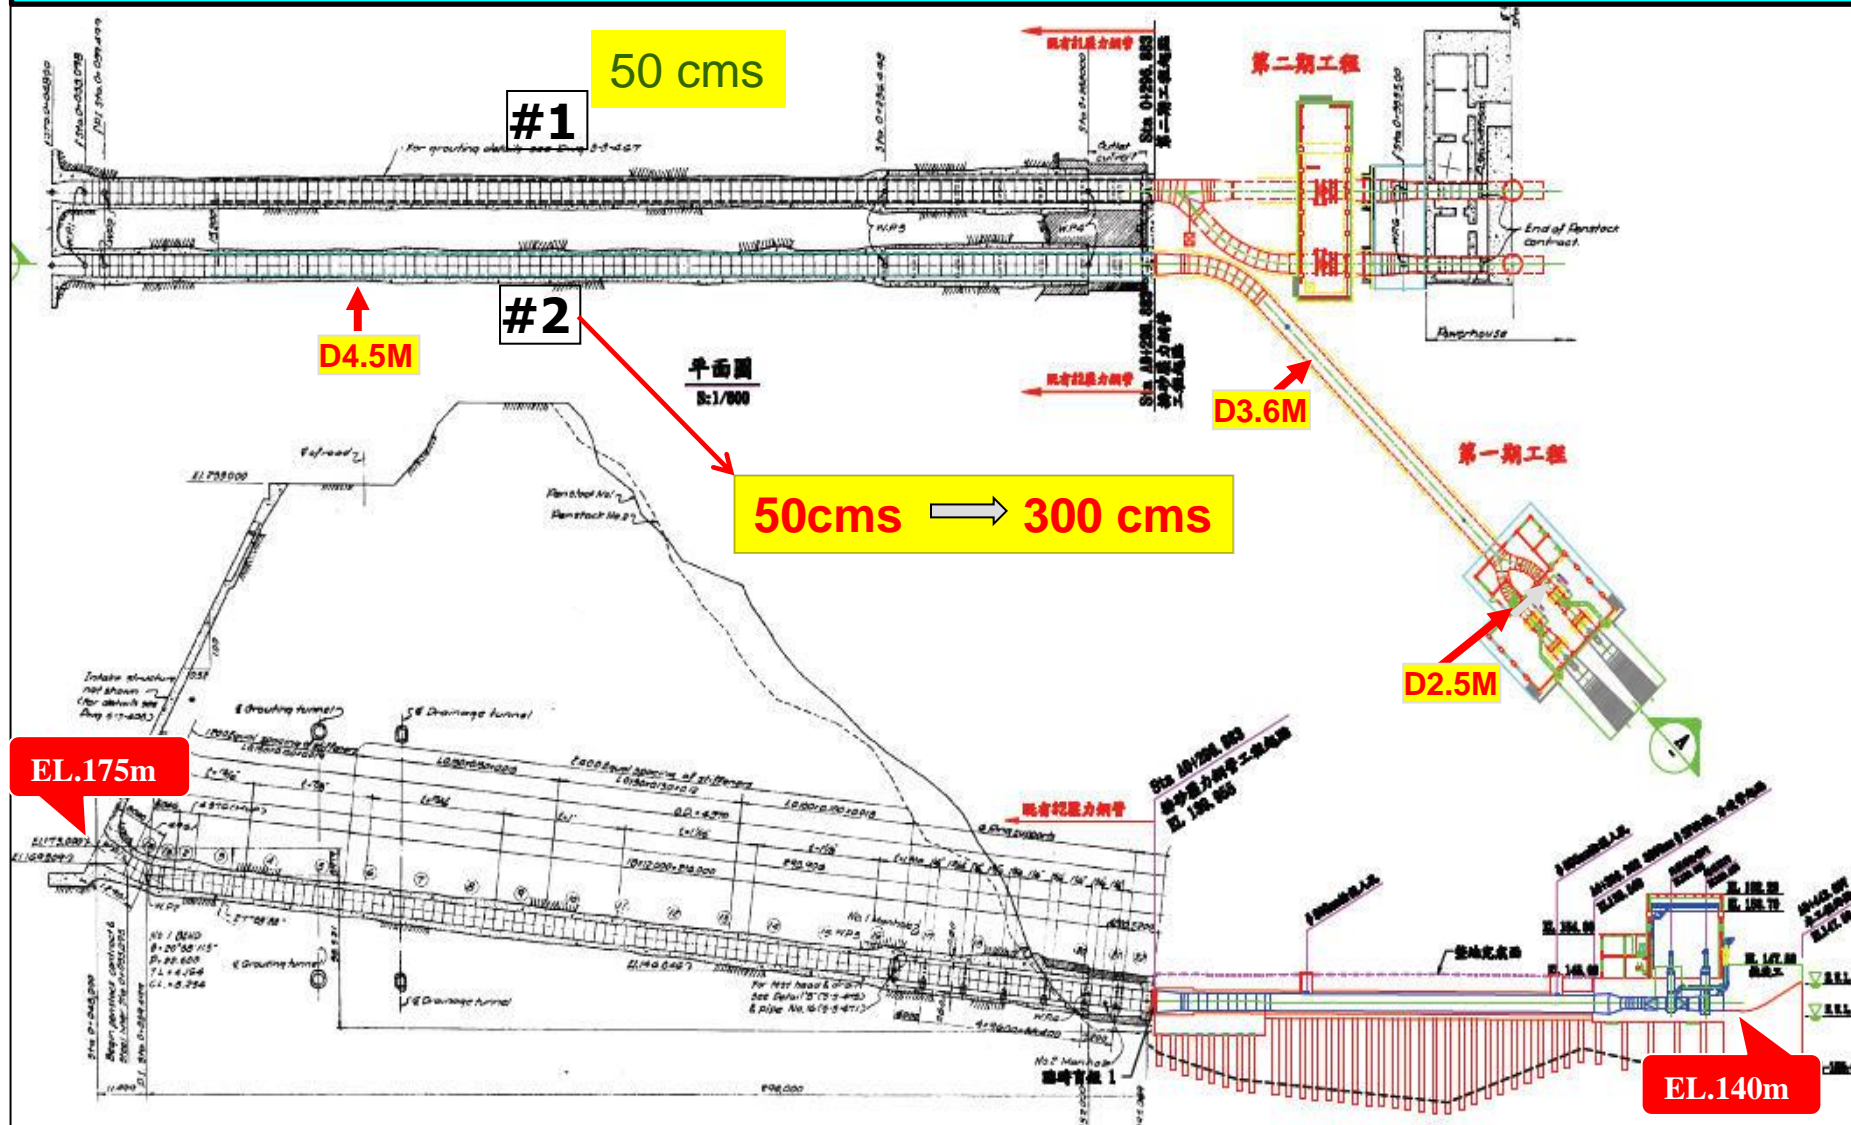
1. Modifying Power Plant #2 Penstock as Sluice Tunnel.

- **Sediment transport(density flow) monitoring data is very useful for sluicing operation.**
- **Modification of power plant penstock as sluiceway can reduce sediment deposition in Shihmen Reservoir.**
- **No matter how effective the sluiceway is, a big portion of sediment was still kept in the reservoir.**

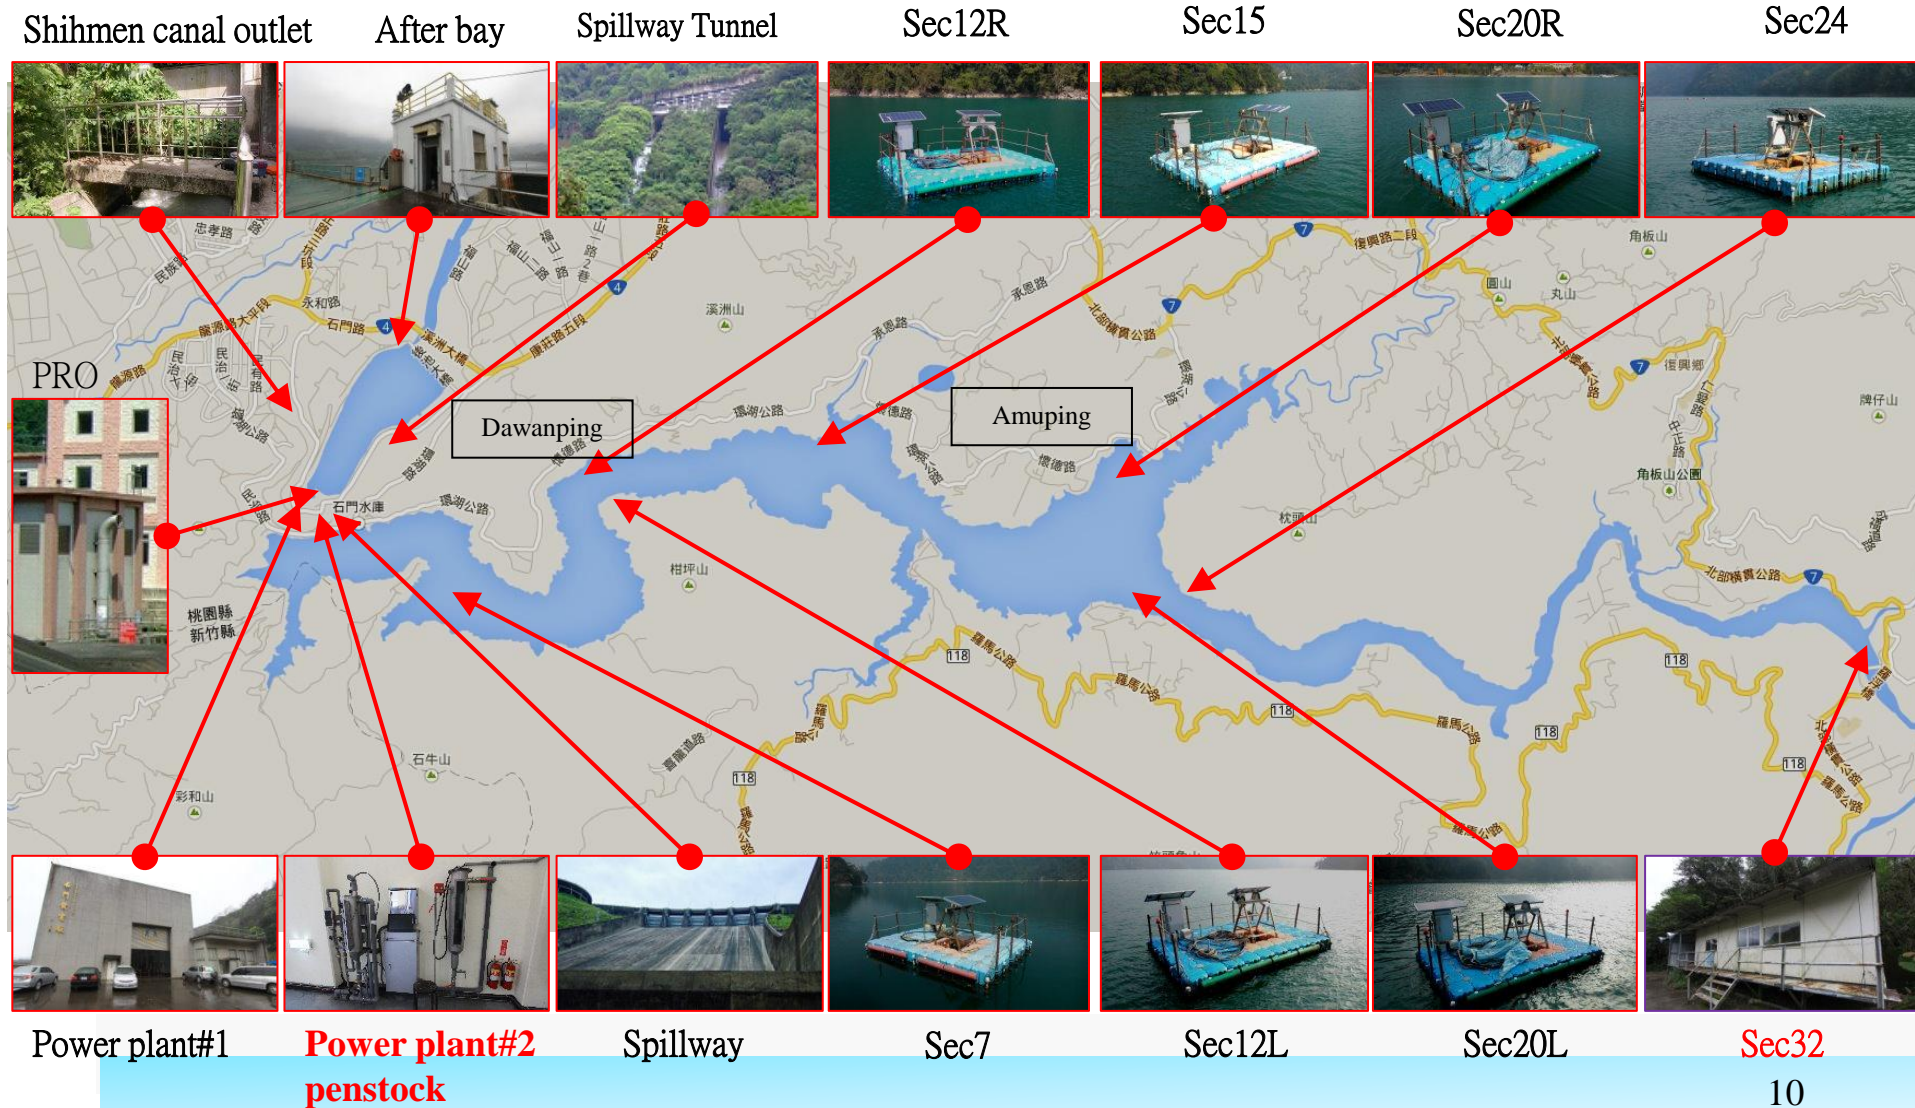
2. Building suspended solid concentration(ssc) monitoring system. (15 stations from after bay to 16km upstream)

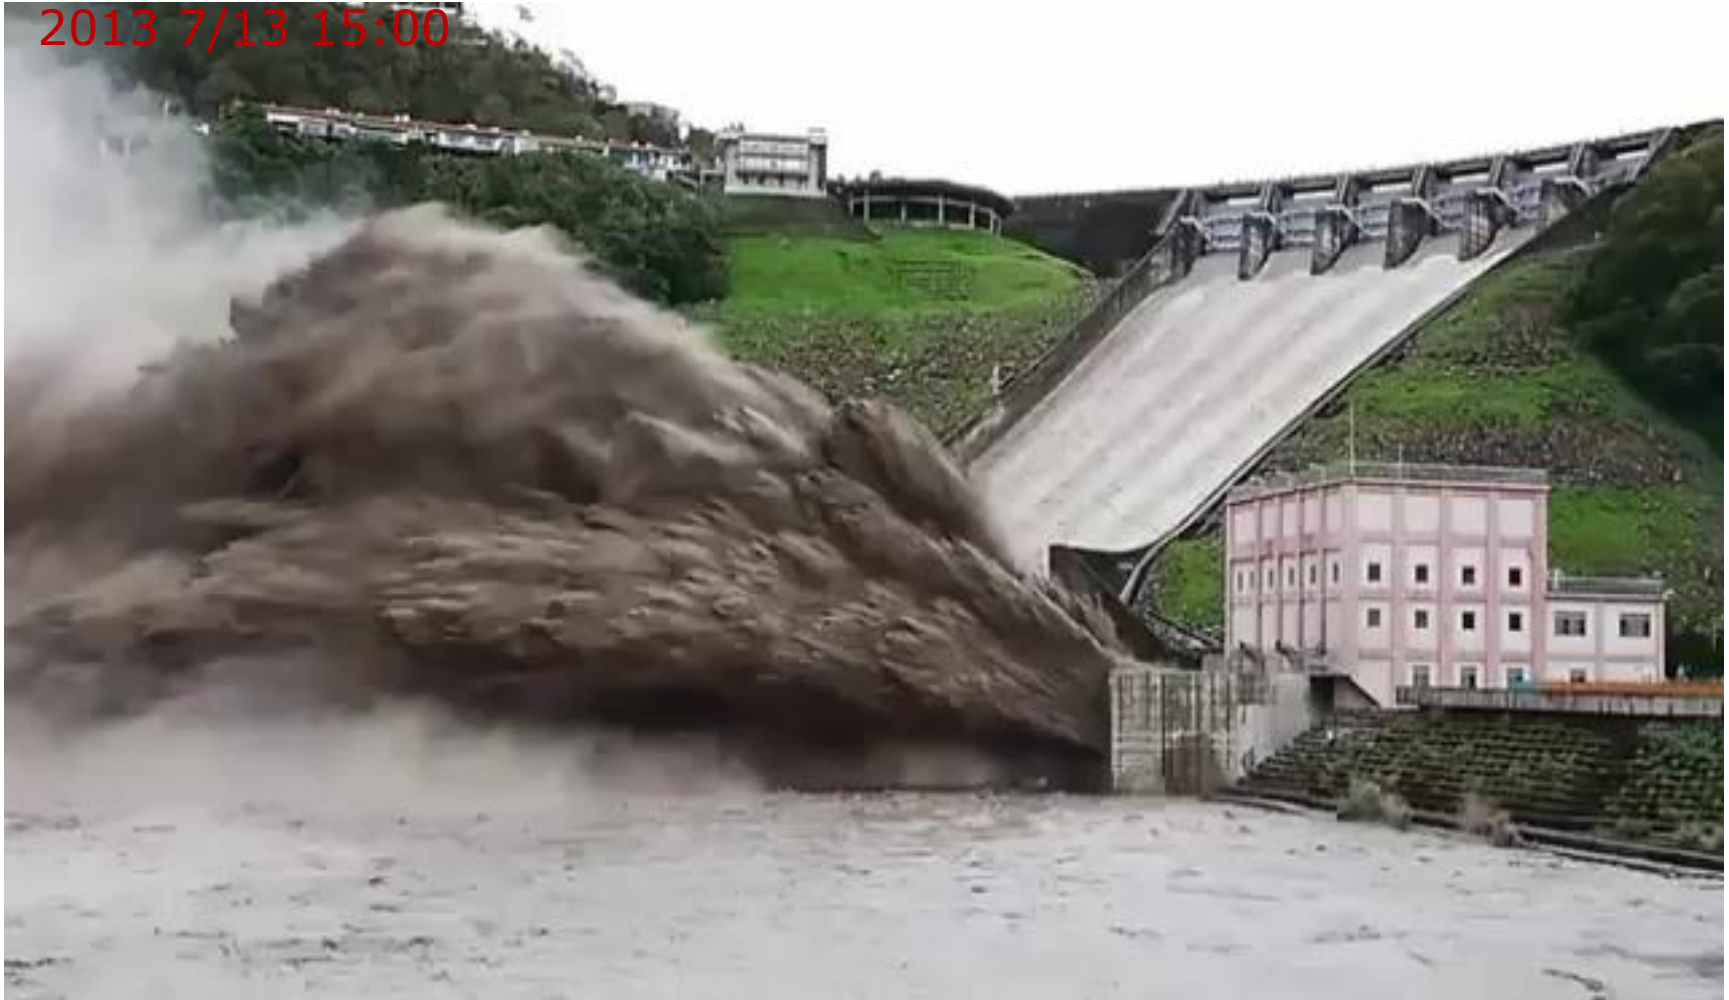
2013 7/13 15:00

Sluicing Operation during Typhoon Soulik (2013)

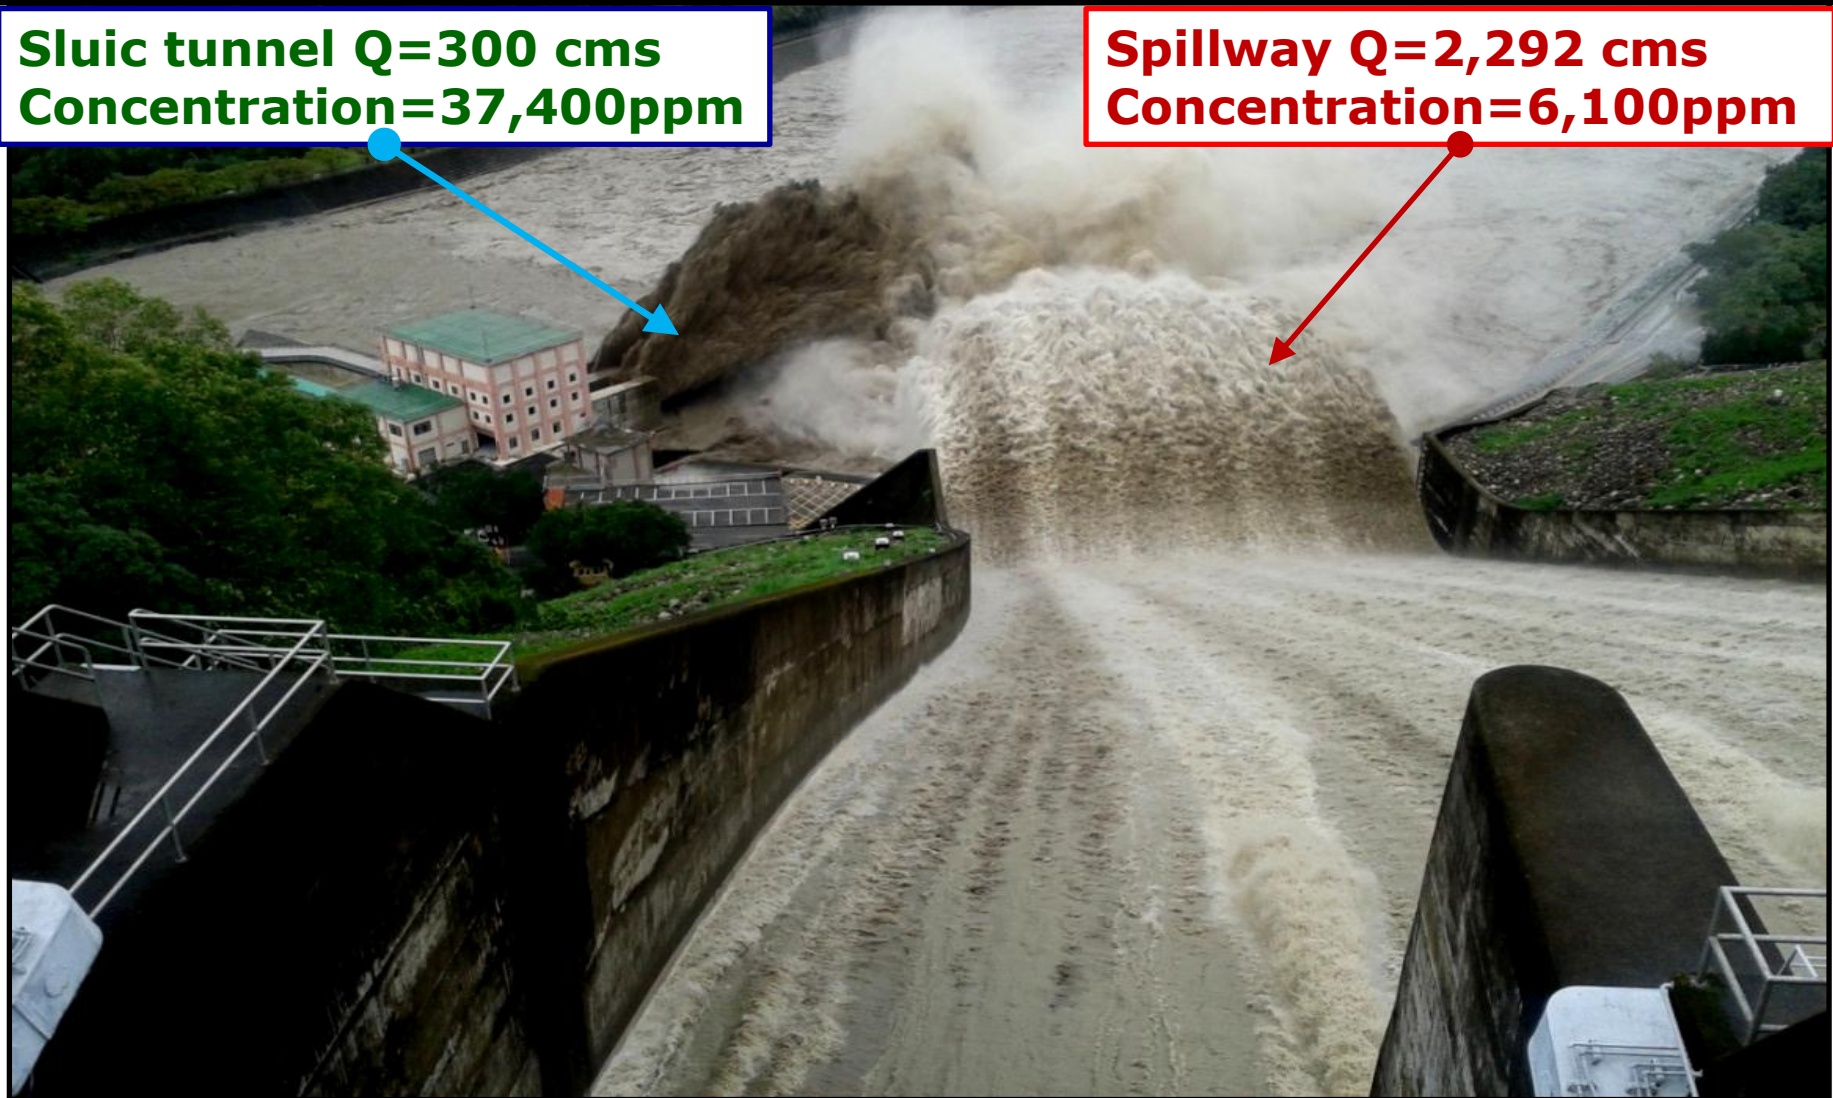
Sluicing Operation during Typhoon Soulik (2013)

**Sluic tunnel $Q=300$ cms
Concentration= $37,400$ ppm**

**Spillway $Q=2,292$ cms
Concentration= $6,100$ ppm**

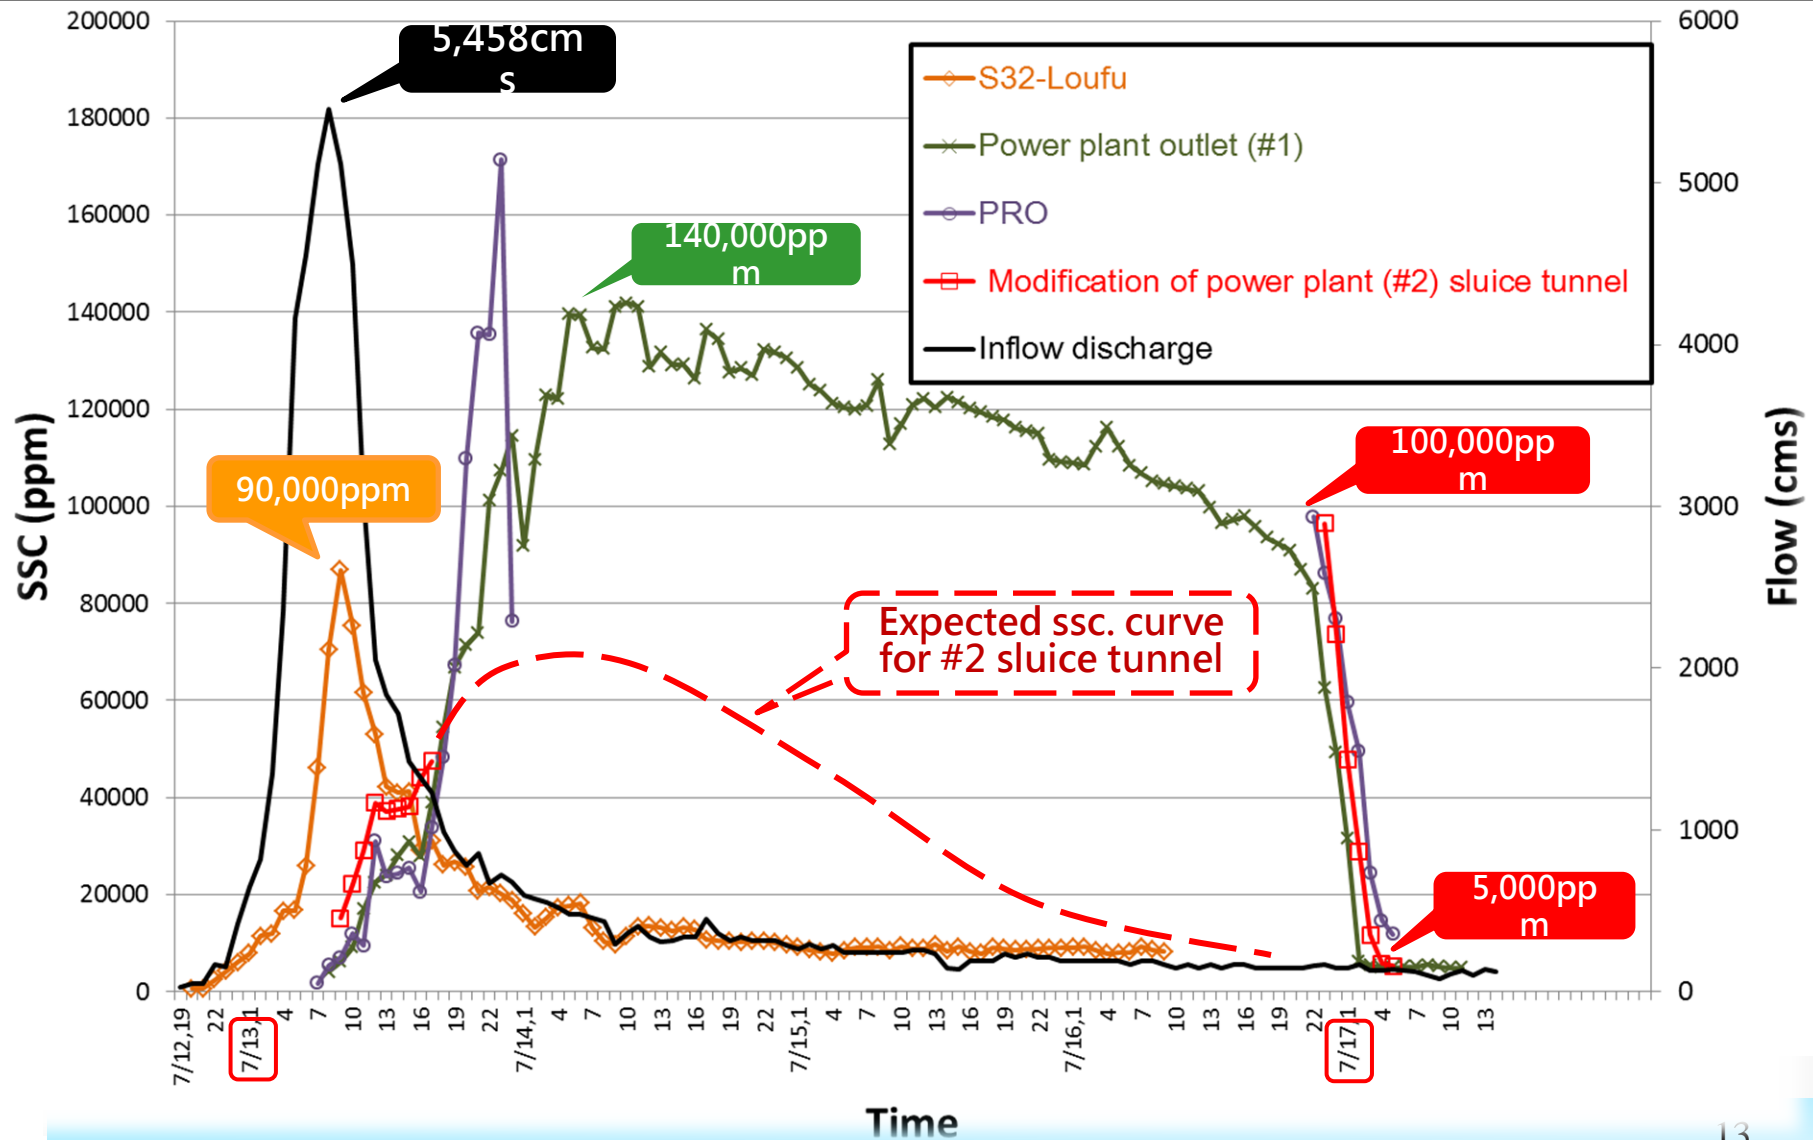
Monitoring Results during Typhoon Soulik (2013)
