Technical Review Report

## 2018 Work Scope for Appendix No. 6 Findings of the Technical Review Team

**Water Resources Agency  
Ministry of Economic Affairs, Taiwan**

Technical Review Report  
2018 Final Report Under Appendix No. 6

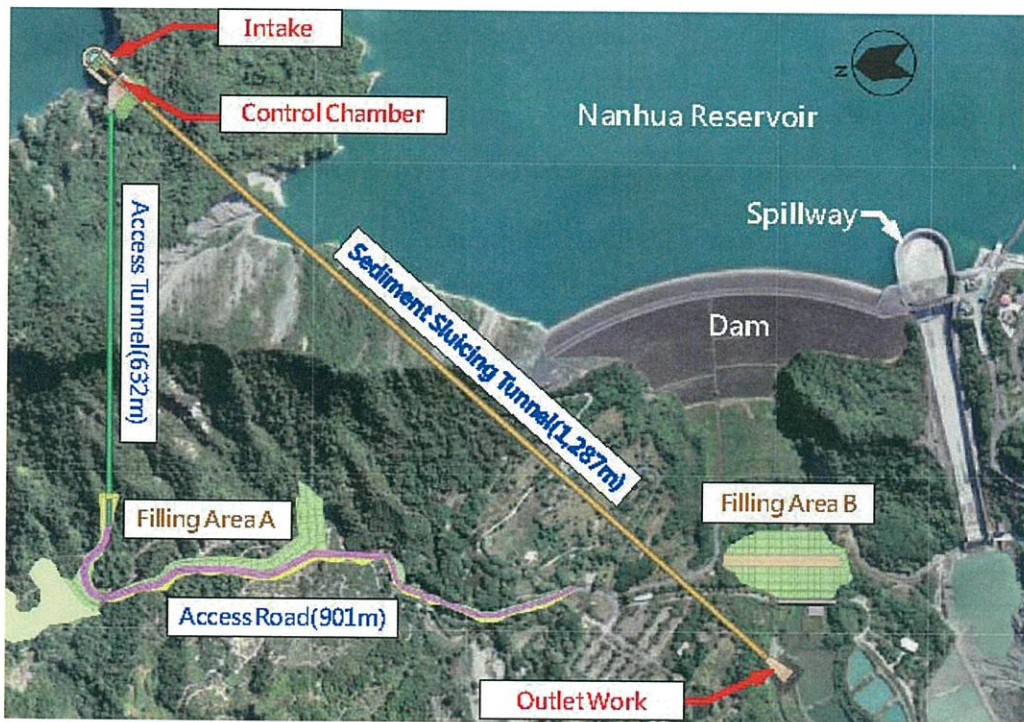
Figure 16. Satellite image plan view of the sediment sluicing tunnel at Nanhua Reservoir

Nanhua Dam and Reservoir are located near Tainan in WRA's Southern Region. Similar to Tsengwen Dam, the Nanhua Reservoir has extreme sedimentation challenges. Specifically, Nanhua Reservoir has experienced a significant loss of storage as a result of sediment deposition in the reservoir resulting in a 39-percent decrease in the design storage volume. Similar to Tsengwen, a new sediment sluicing tunnel was constructed in 2017. Design features included an intake structure followed by a 52-meter-long intake tunnel, a gate chamber with vertical access shaft, a 1,290-meter-long sediment sluicing tunnel, an outlet structure, and an access tunnel. The plan configuration of the project is shown in figure 16.

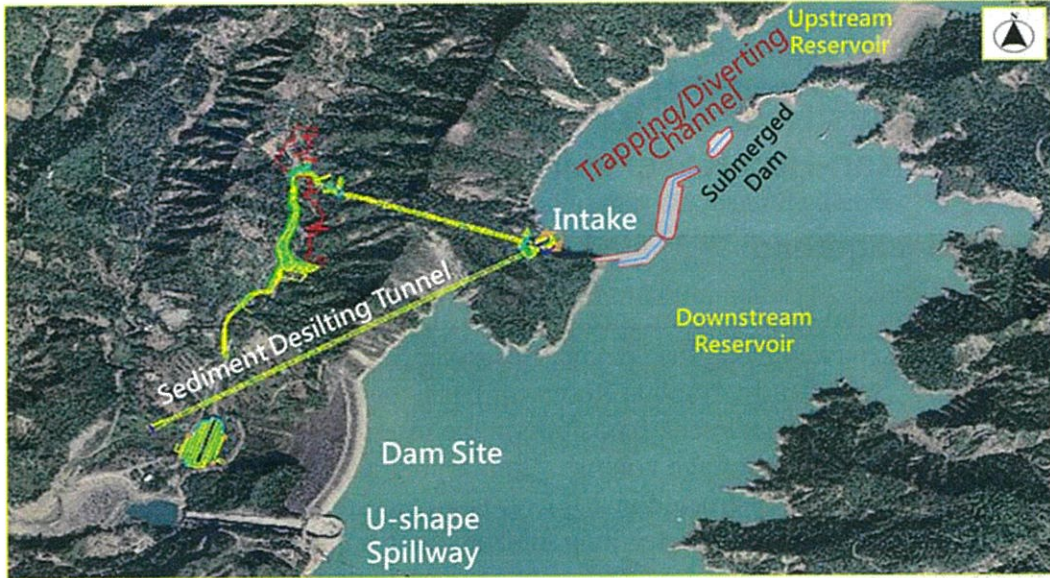
Figure 17. – Proposed location of submerged weir and desilting tunnel at Nanhua Reservoir.

To supplement the sediment reducing efforts at Nanhua, a submerged weir structure has been proposed and a feasibility level design has been completed as shown in plan view on Figure 17 and in cross section in Figure 18.

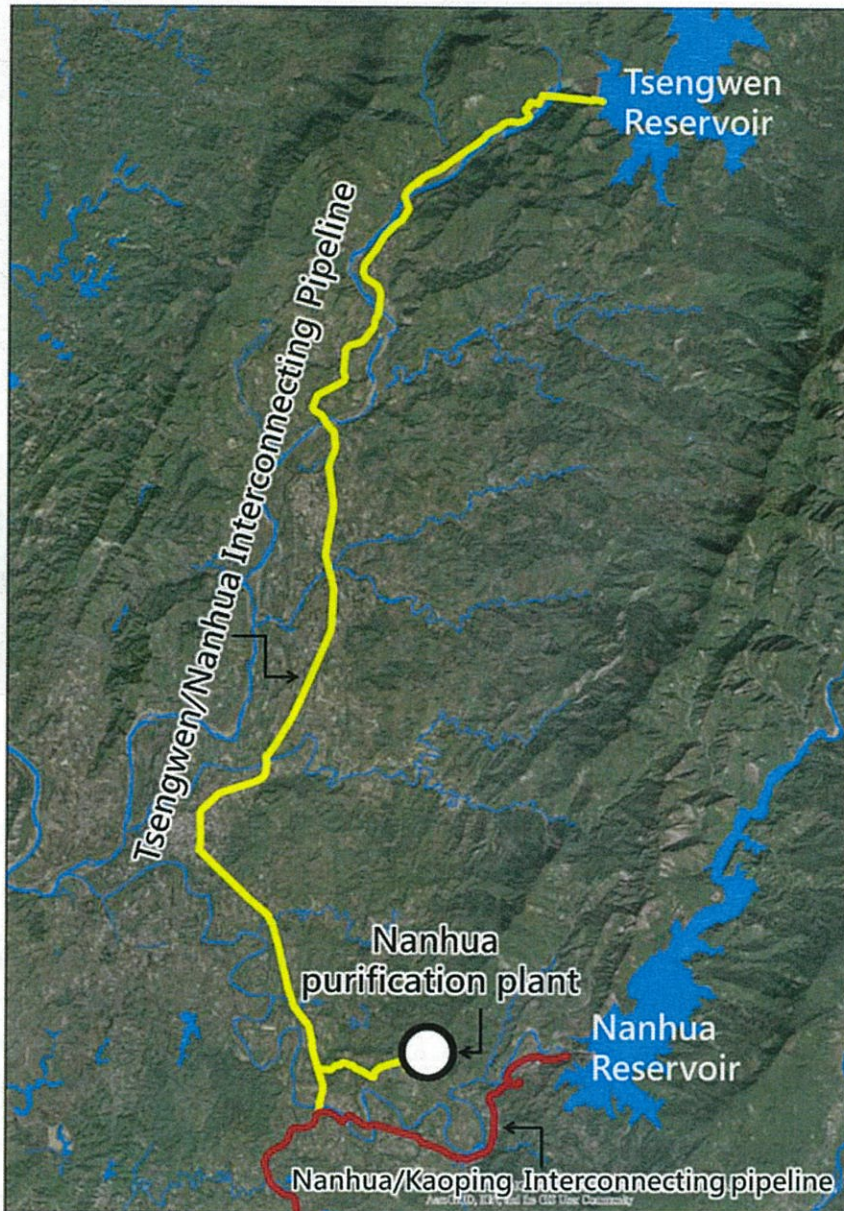
Figure 20. Plan Layout of Tsengwen/Nanhua Interconnecting Pipeline

To enhance water resources management and to provide regional potable-water backup during drought, a pipeline is currently being designed to link Tsengwen Reservoir with the Nanhua Purification Plant and the Nanhua/Kaoping pipeline. The total length of the new pipeline is about 23km and the designed delivery capacity is 800,000m<sup>3</sup>/day. The overall layout of the interconnecting pipeline is shown in figure 20.

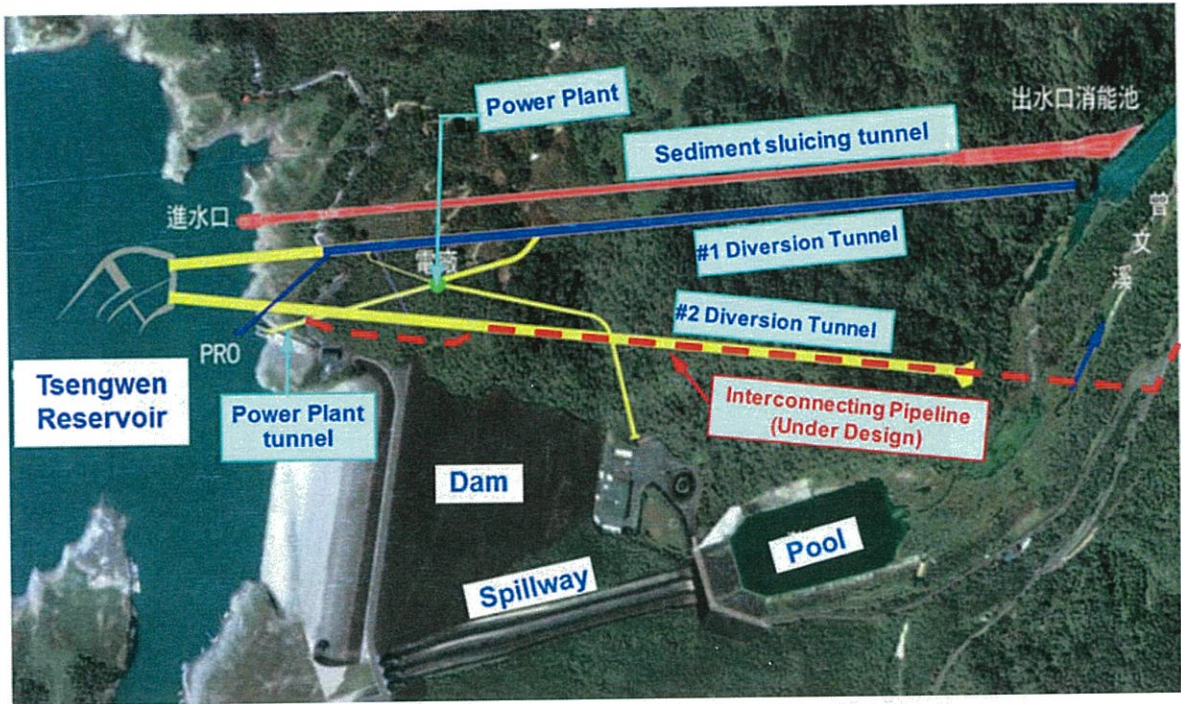
Figure 21. - Plan View of Intake Segment of the Tsengwen/Nanhua Interconnecting Pipeline

The pipeline will connect to the power penstock of the Tsengwen powerplant via a new 4.5m diameter tunnel bored from the existing 12m diameter Diversion Tunnel No. 2. The pipeline will then be installed along the diversion tunnel and cross beneath Tsengwen River bed and convey flows downstream to the Nanhua Purification Plant or to the basin downstream of Nanhua Reservoir. Flow rate of this pipeline will be regulated by a fixed cone valve. The layout of the new intake tunnel is shown below in Figures 21 and 22.
