摘要

本計畫為『108年度阿公店水庫大壩安全檢查及監測分析』，由經濟部水利署南區水資源局委託黎明工程顧問股份有限公司辦理。計畫目的係利用大壩埋設之監測儀器，於水庫營運期間持續辦理監測，並對大壩進行定期或不定期安全檢查，以維水庫營運期間之壩體安全性。相關工作內容及重點概述如下：

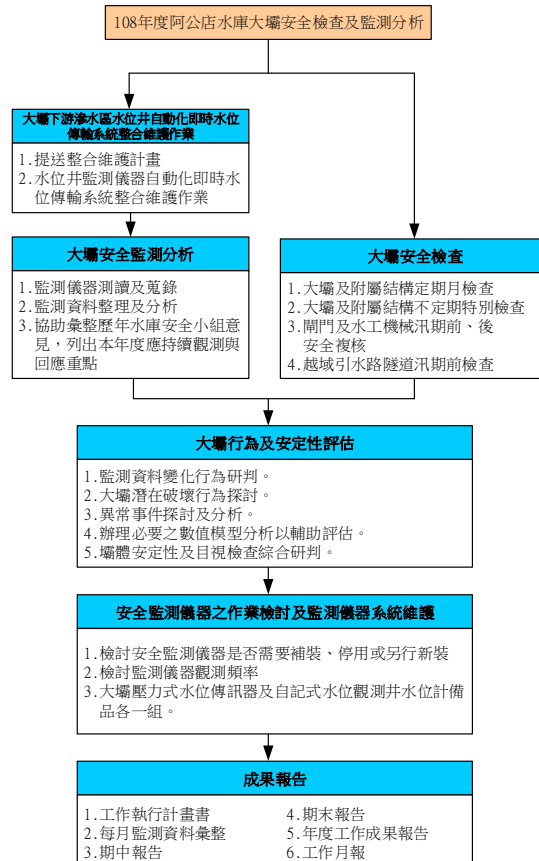
圖摘-1 本計畫工作計畫流程圖

阿公店水庫為一防洪為主要目標之水庫，為解決日趨嚴重之淤積、供水及滯洪空間不足等問題，維持防洪、灌溉、公共給水等多目標功能，特於民國86年起進行更新改善計畫，至民國95年完工，為臺灣舊水庫再造之最佳案例。為確保水庫蓄水營運期間之壩體安全性，以提供水庫下游民眾生命財產之安全保證，計畫執行期間配合其相關設施進行安全監測分析及檢查，工作內容包括：1.大壩安全監測分析；2.大壩安全檢查；3.越域引水路隧道汛期前檢查；4.大壩行為及安定性評估；5.安全監測儀器作業檢討及監測儀器系統維護；6.大壩下游滲水區水位井自動化即時水位傳輸系統整合維護；7.工作簡報及報告編撰印製等。
